# Measures to make Horikawa River Limpid.

## Implementation by Nagoya City.

Feb.15th.2014

Nagoya City Greenification & PublicWorks Bureau River Dep.  
River Planning Div.

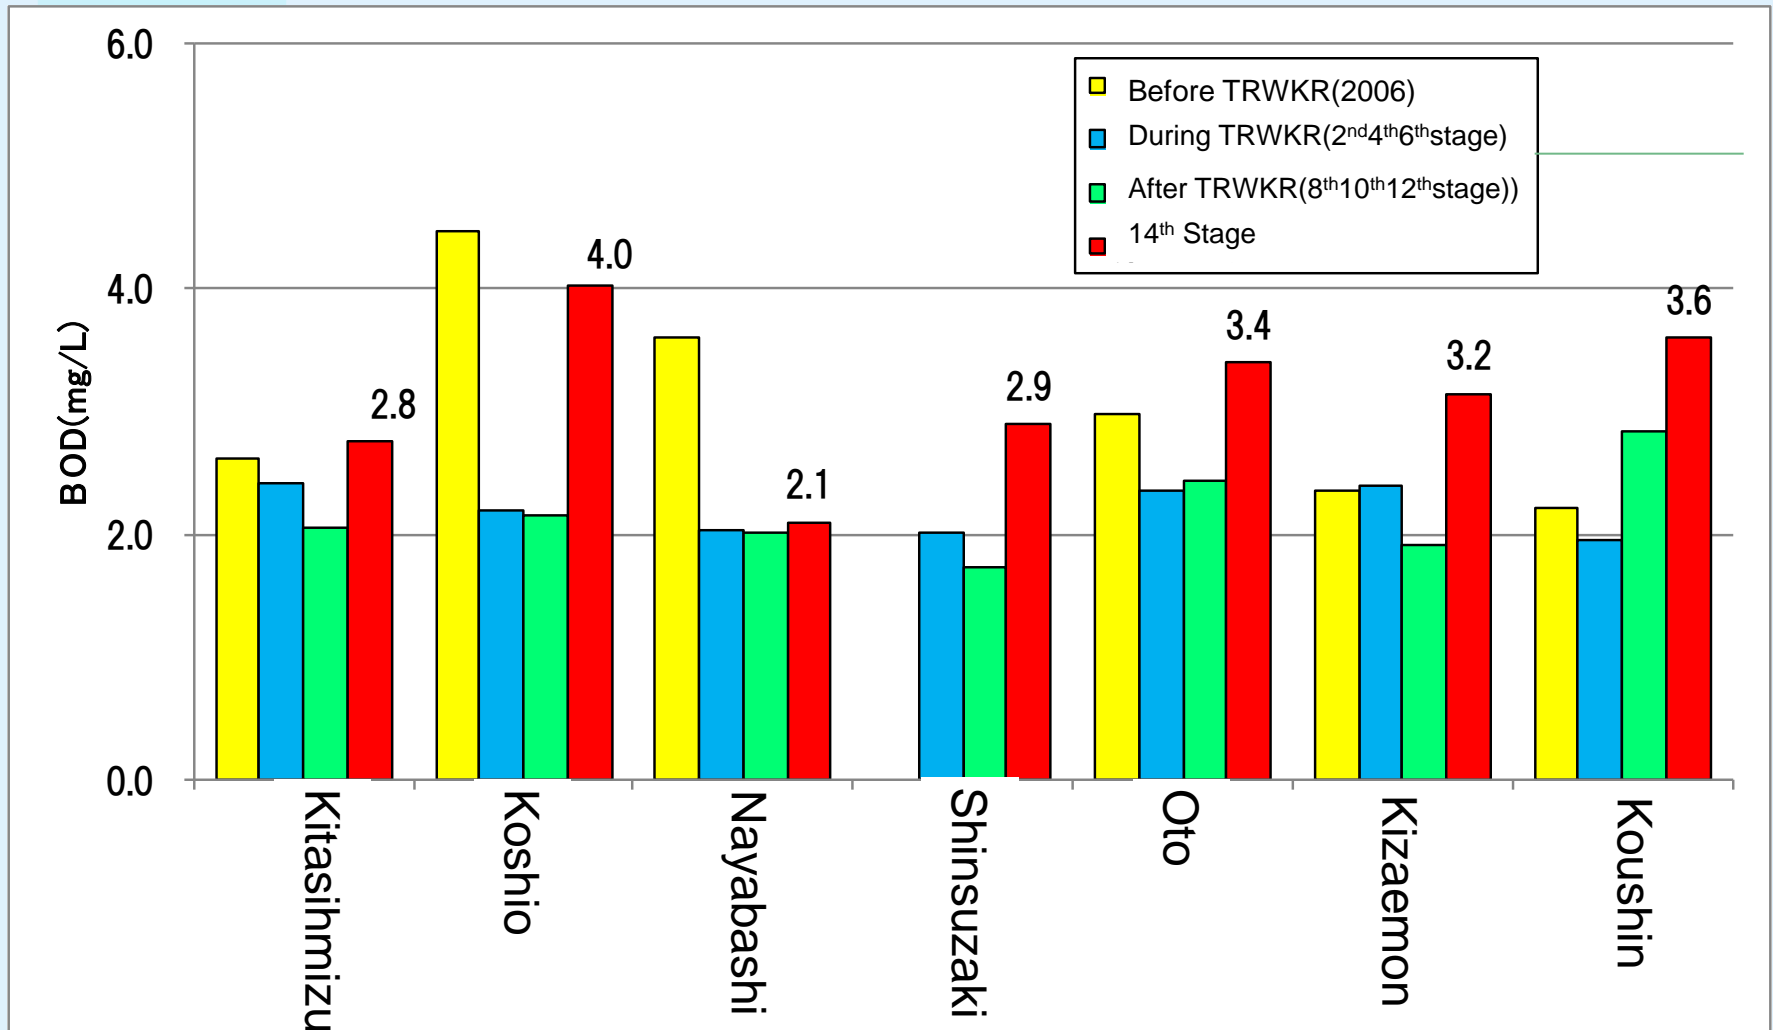
BOD

**BOD level was high on 14th stage at all points(without Nayabashi Bridge)**

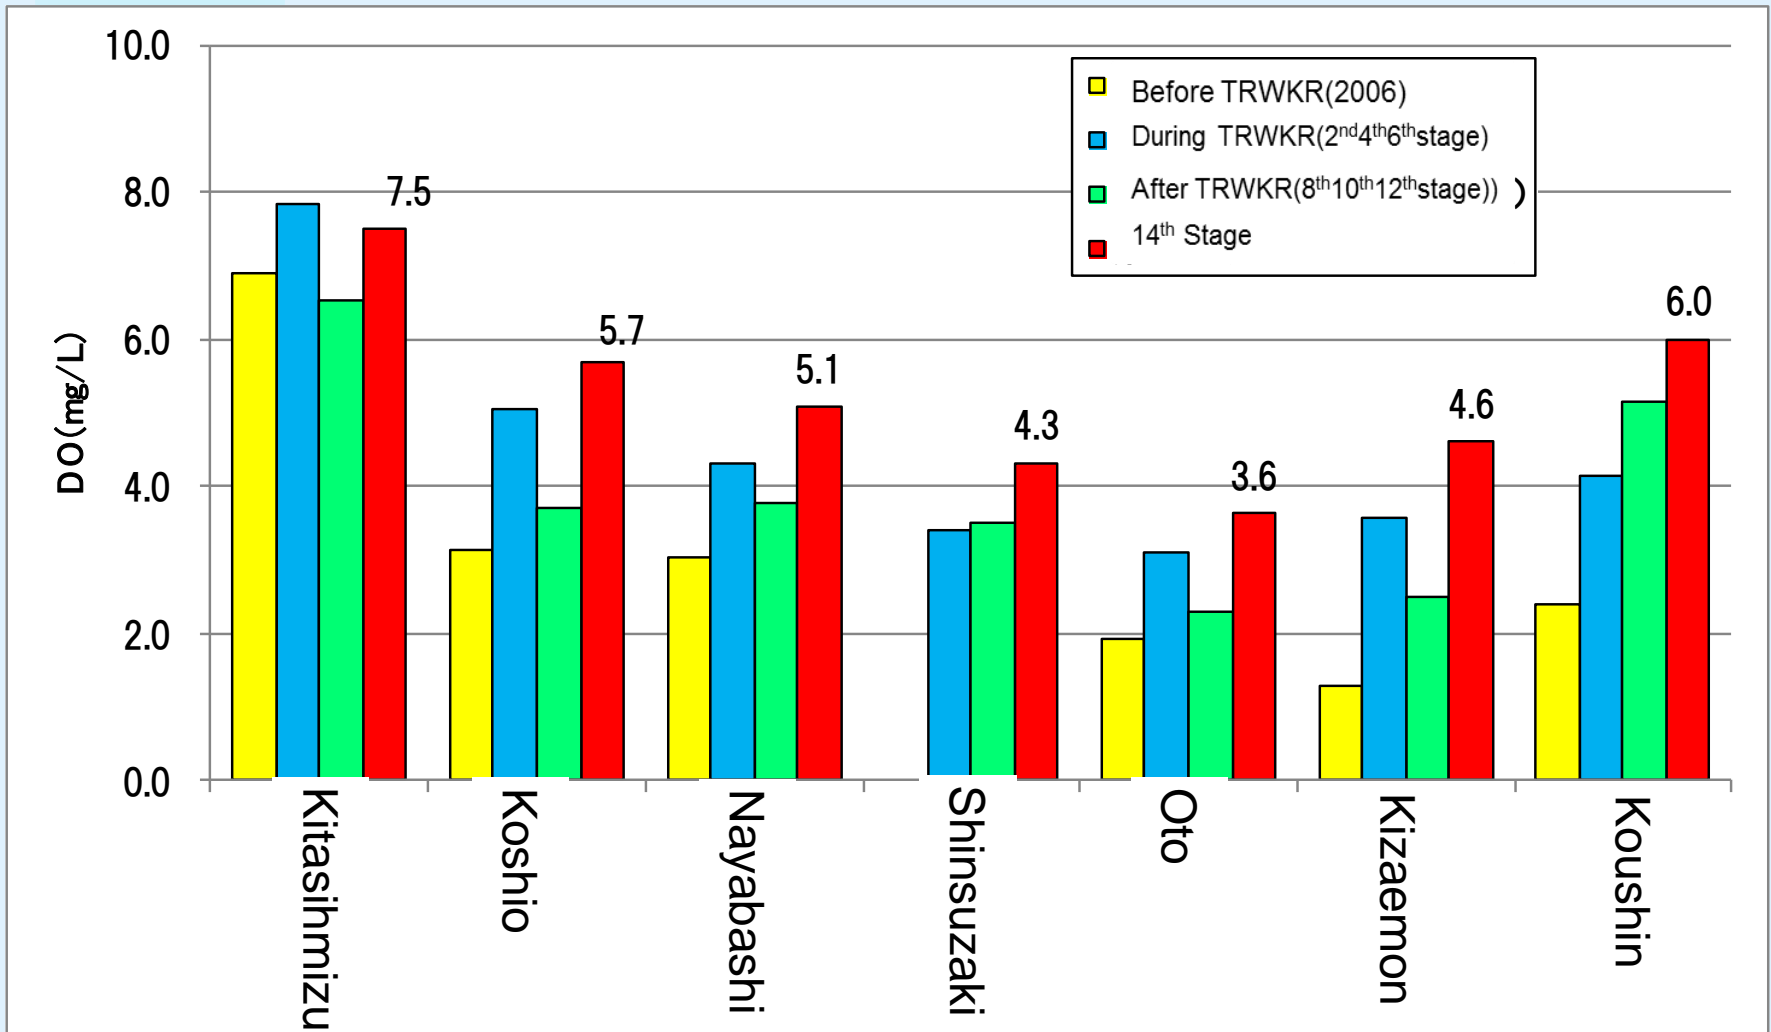
DO

**DO level was higher on 14<sup>th</sup> stage than during TRWKR at all points without Kitashimizu Bridge near Sanage Bridge.**

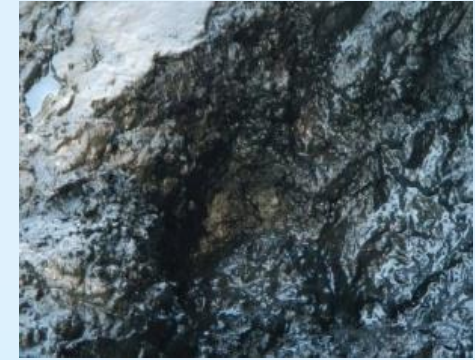
Sludge on surface

- Sludge layer is about 30cm thick on average (min 4cm, max 66cm)
- there are many stones on the lower layer at the almost all points

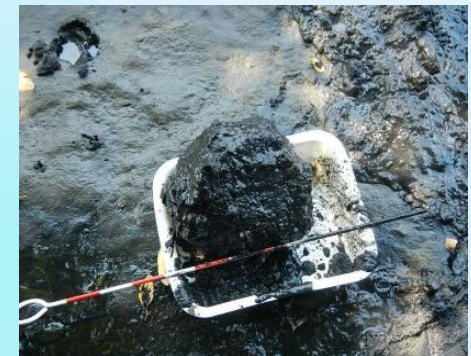
Stones of the lower layer

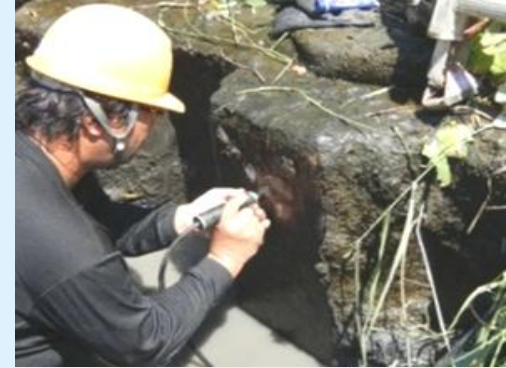
Measuring of Sheet pile thickness

- We found the standard of the sheet pile. The sheet pile has not been repaired and embedment depth is shallow.
- We found erosion of an exposed part and deteriorated part.
- As the result of this survey and the stability analysis, we found it hard to remove sediment on the sheet pile.
- Revetment become more instable when the water level is low.

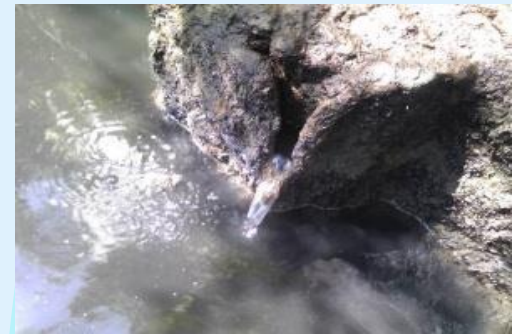
Becoming hollow at sheet pile damaged
