Measures to make Horikawa River Limpid

Implementation by Nagoya City

**Nagoya City Greenification & Public Works Bureau
River Dep. River Plannning Div.**

Outline of Clarification Experiments by Covering Sand

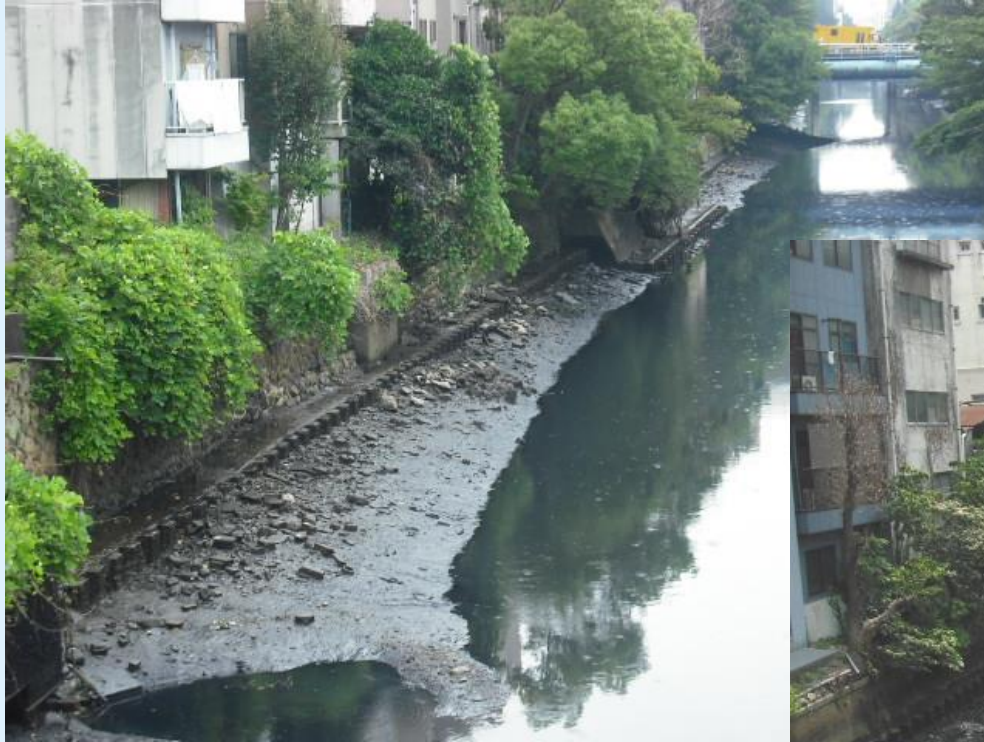
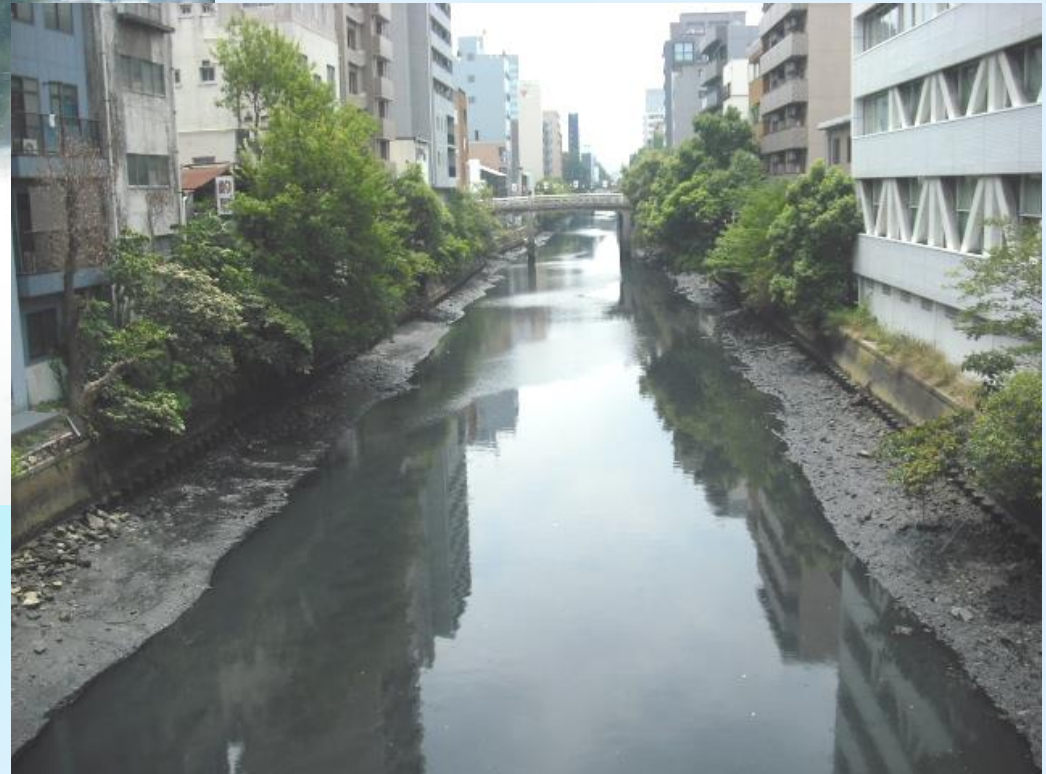
Sludge appearing from riverbed on the ebb tide.

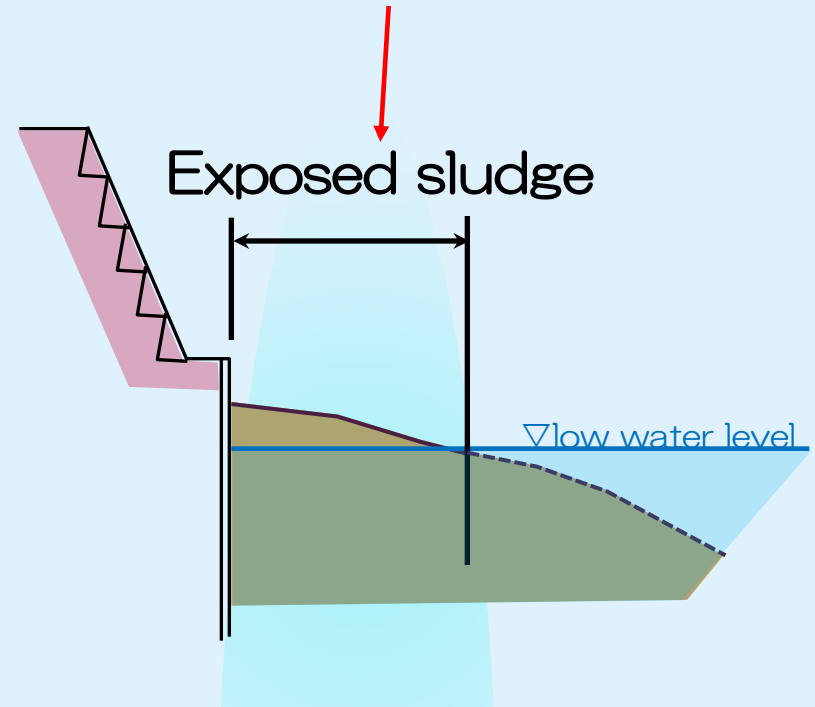
Location

- about 300m long
(600m on both sides)
- 3m wide on each side

- 5 kinds of trial pattern
in this section

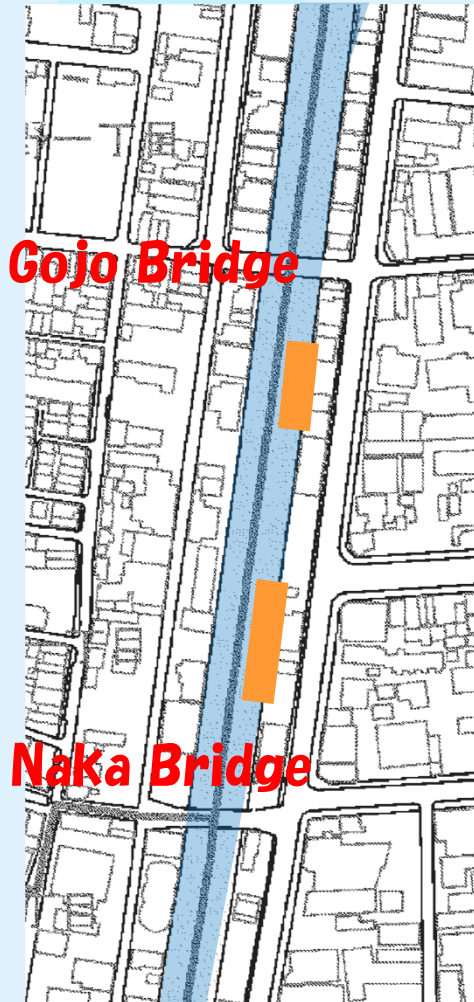
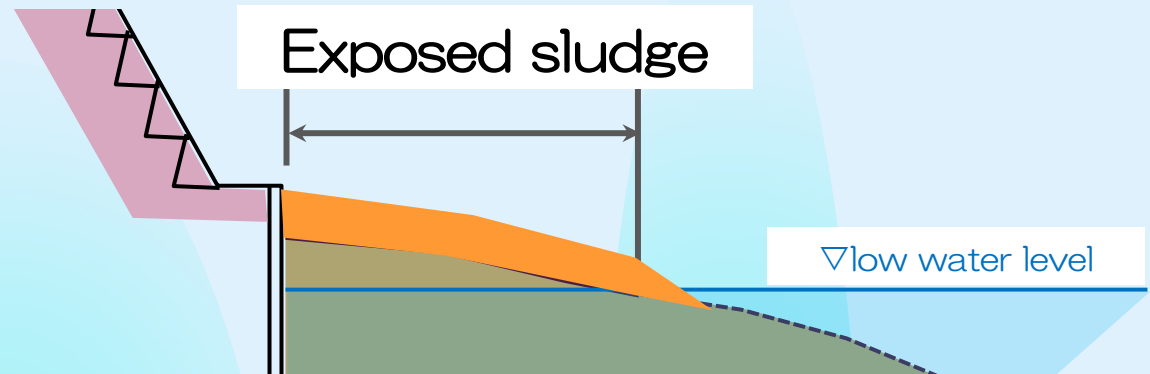
① covering sand

cover the sludge with 30cm thick sand bed

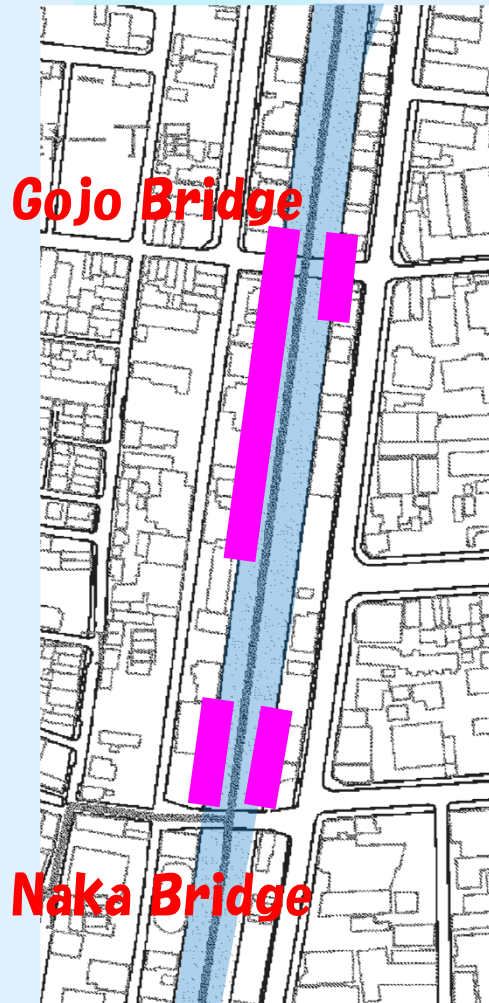
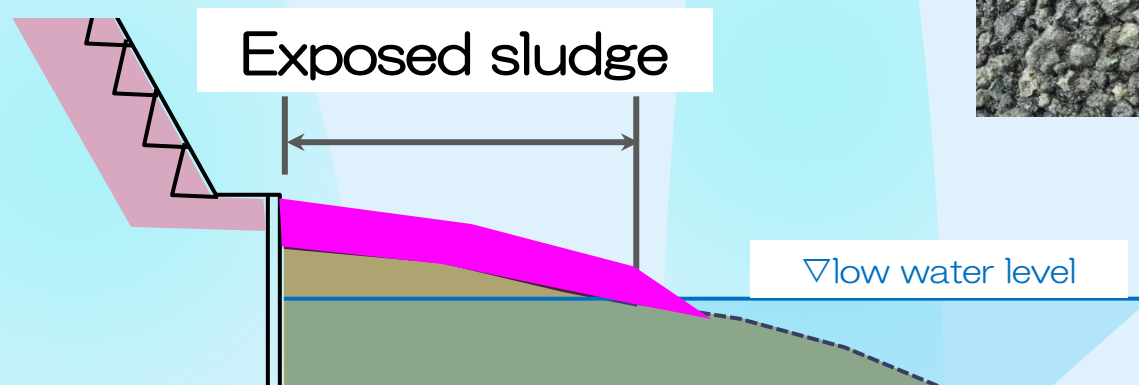
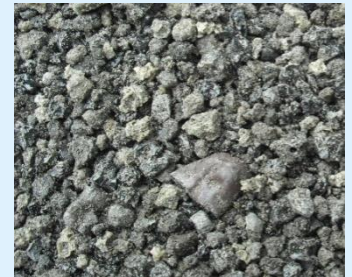
② cover with clarification materials

cover the sludge with 30cm thick clarification materials made from ash (by-product of coal thermal power station) and absorbing for its porousness

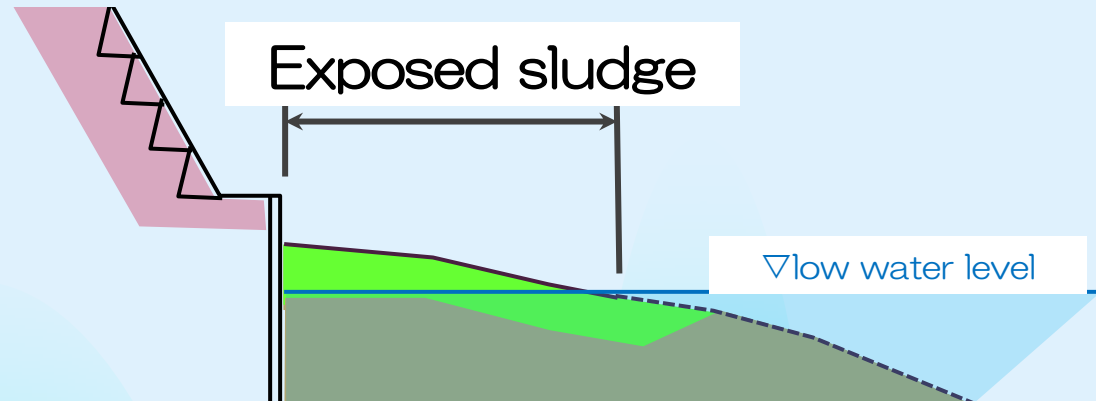
■ Experiment ③ covering sand after removing sludge

remove 30cm thick sludge and cover with 30cm thick sand bed

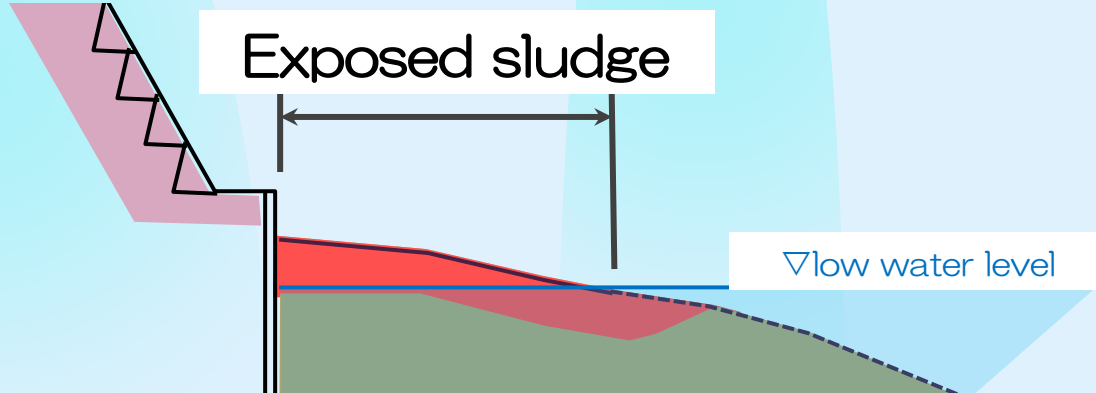
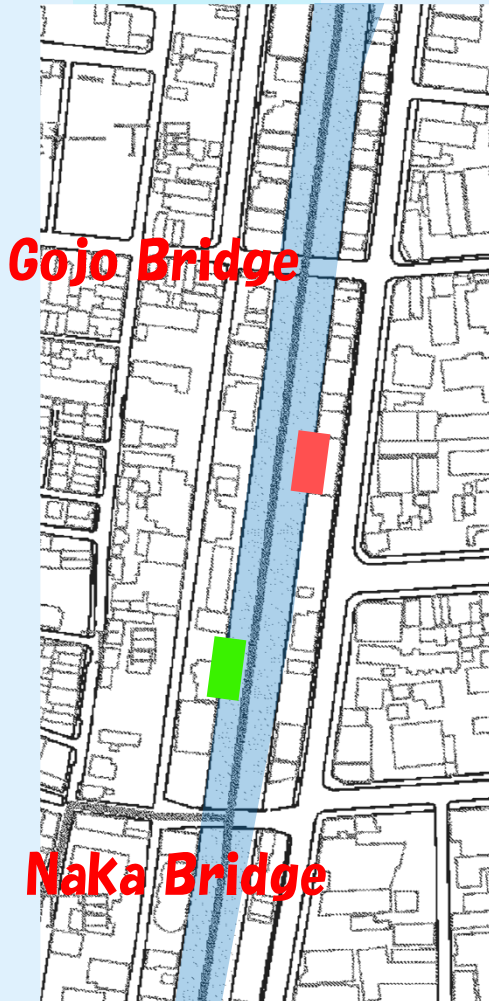
④ cover with clarification materials

remove 30cm thick sludge and cover with 30cm thick clarification materials

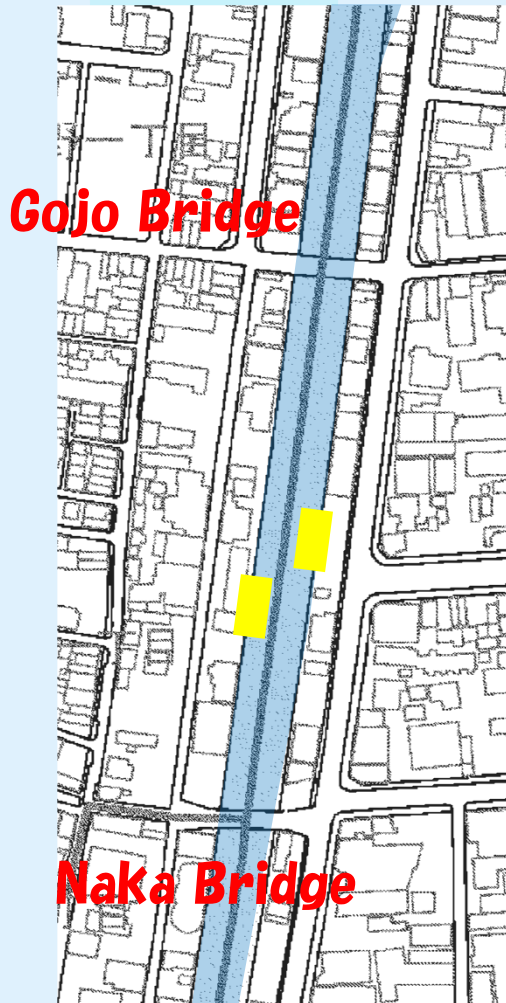
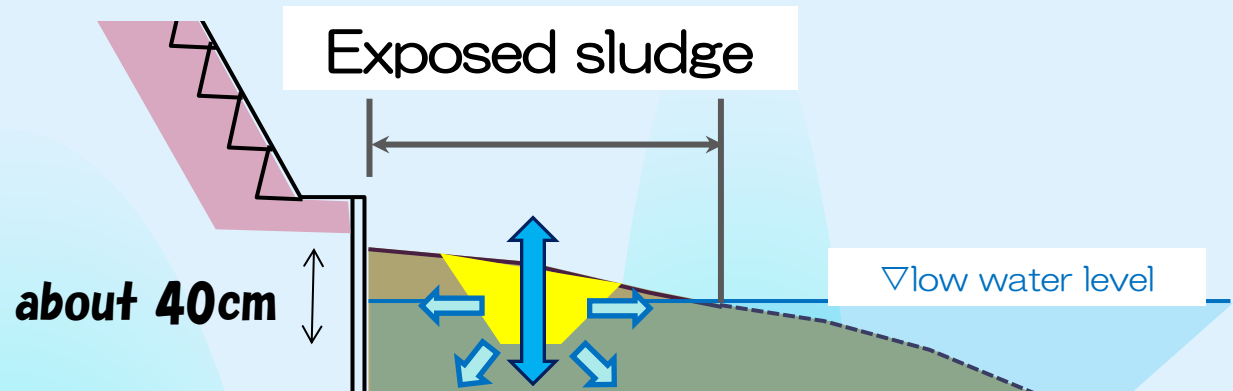
⑤ settle infiltrators

settle corn-shaped infiltrators made with solid clinker ash every 1m through sludge

[mechanism of infiltrator]

- make stream inside the facilities by ebb and flow
- supply oxygen into the bottom

⇒ improve the bottom layer

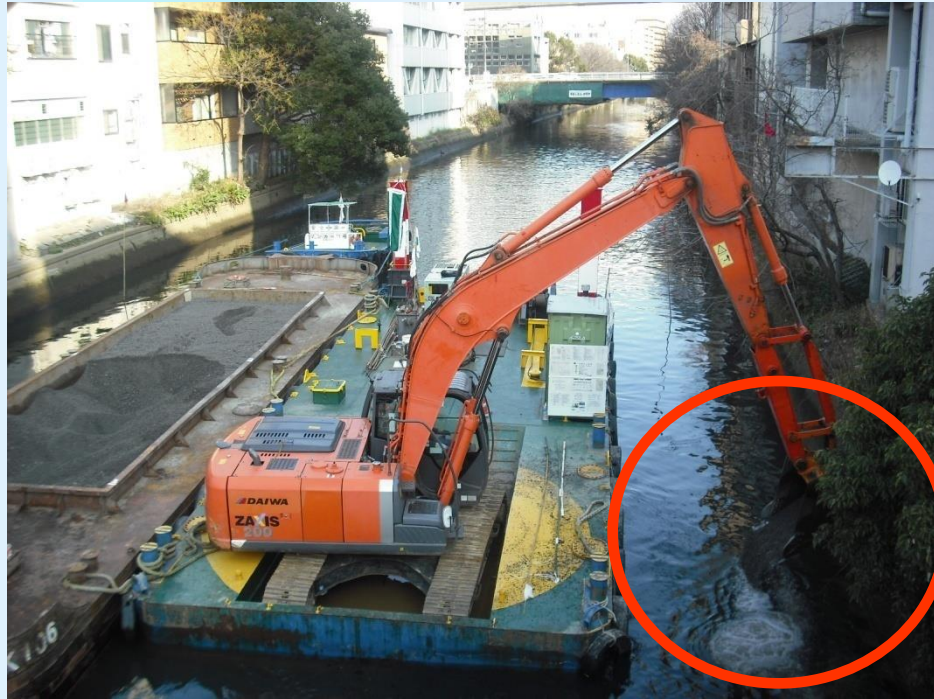
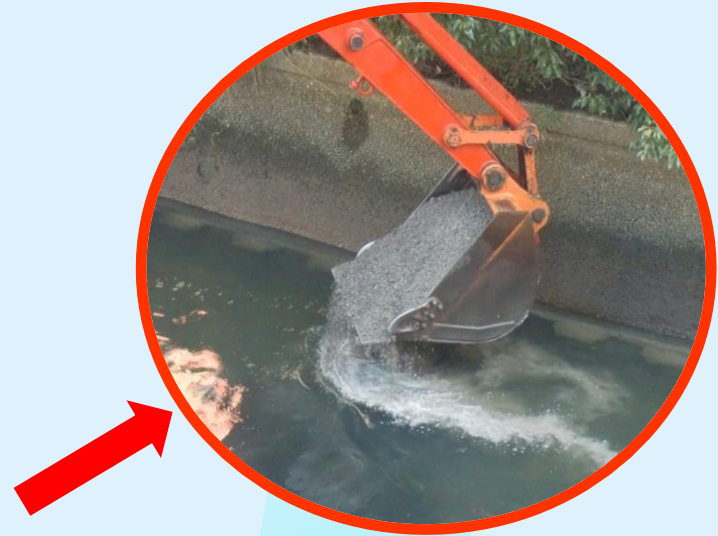
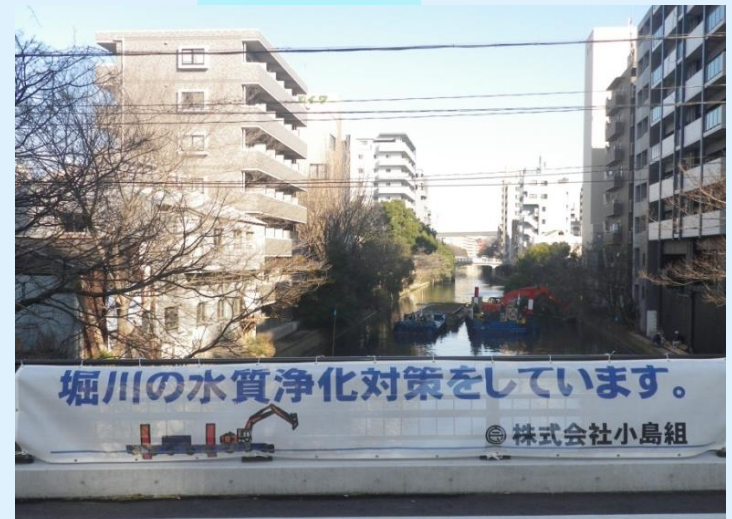
Construction of the experiment site

from Jan.16 to Jan.23

**Machines set on a float
constructed the experiment site.**

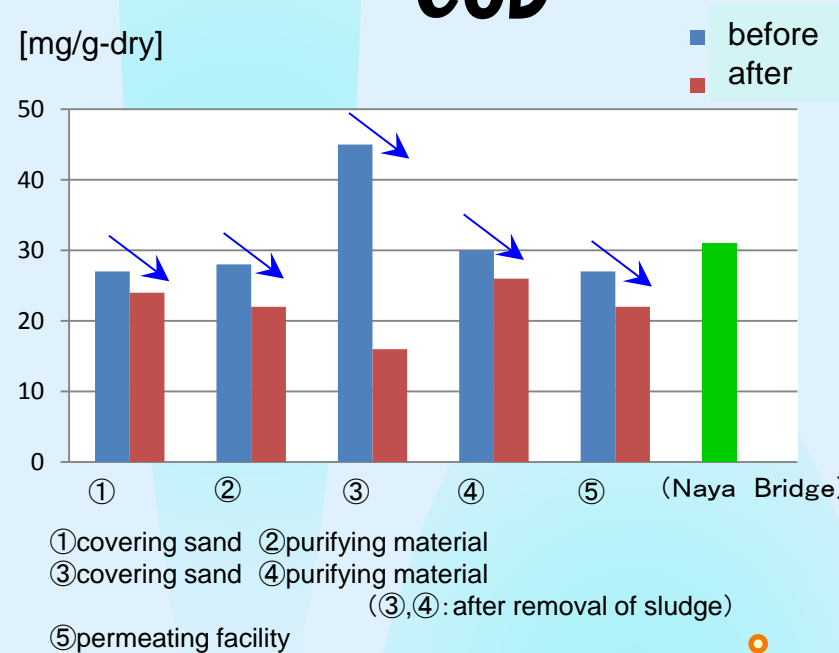
→ improved
→ not improved

COD improved in all sections

| | point | ①covering sand | | ②purifying material 【coal ash】 | | ③covering sand (after removal of sludge) | | ④purifying material 【coal ash】 (after removal of sludge) | | ⑤permeating facility 【coal ash】 | |
|---|---|---|---|---|---|--|---|--|---|---|---|
| | COD (mg/g-dry) | 27 | 24 | 28 | 22 | 45 | 16 | 30 | 26 | 27 | 22 |

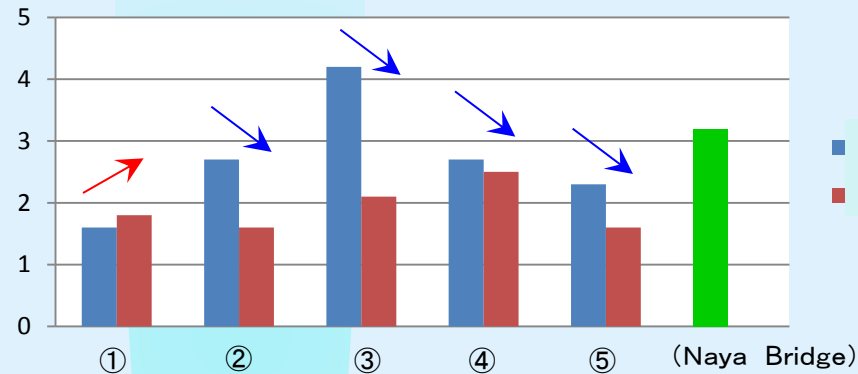
T-N (total nitrogen)

organic matter and nutritious salt decreased.

[mg/g-dry]

①covering sand ②purifying material
③covering sand ④purifying material (③,④: after removal of sludge)
⑤permeating facility

→ improved
→ not improved

| | point | ①covering sand | | ②purifying material 【coal ash】 | | ③covering sand (after removal of sludge) | | ④purifying material 【coal ash】 (after removal of sludge) | | ⑤permeating facility 【coal ash】 | |
|---|---|---|---|---|---|--|---|--|---|---|---|
| | T-N(mg/g-dry) | 1.6 | 1.8 | 2.7 | 1.6 | 4.2 | 2.1 | 2.7 | 2.5 | 2.3 | 1.6 |

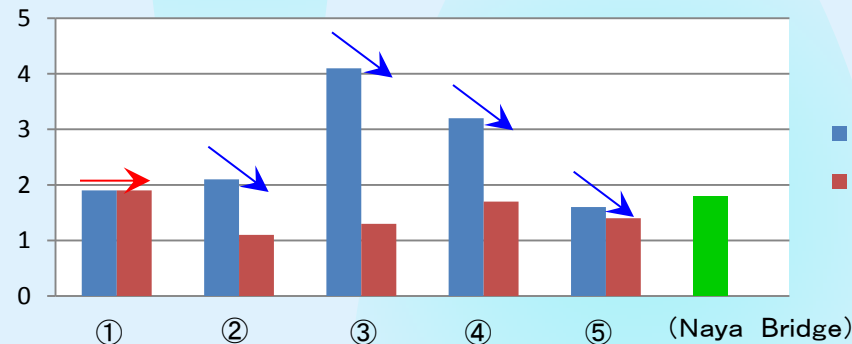
T-P (total phosphorus)

[mg/g-dry]

①covering sand ②purifying material
③covering sand ④purifying material (③,④: after removal of sludge)
⑤permeating facility

| | point | ①covering sand | | ②purifying material 【coal ash】 | | ③covering sand (after removal of sludge) | | ④purifying material 【coal ash】 (after removal of sludge) | | ⑤permeating facility 【coal ash】 | |
|---|---|---|---|---|---|--|---|--|---|---|---|
| | T-P(mg/g-dry) | 1.9 | 1.9 | 2.1 | 1.1 | 4.1 | 1.3 | 3.2 | 1.7 | 1.6 | 1.4 |

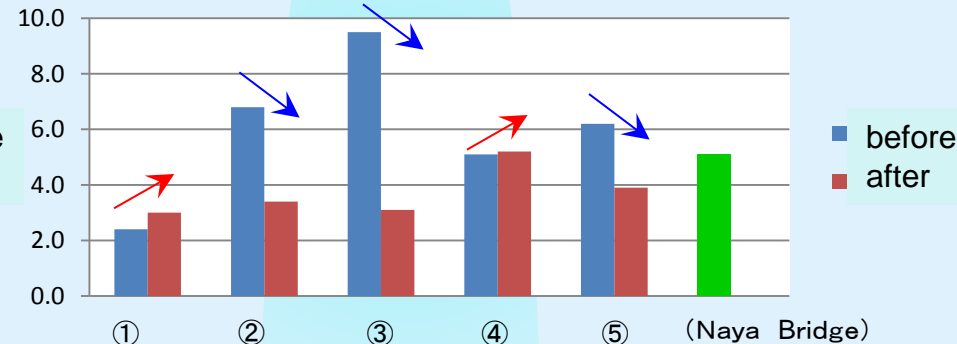
T-C (total carbon)

[%]

①covering sand ②purifying material
③covering sand ④purifying material (③,④: after removal of sludge)
⑤permeating facility

| | point | ①covering sand | | ②purifying material 【coal ash】 | | ③covering sand (after removal of sludge) | | ④purifying material 【coal ash】 (after removal of sludge) | | ⑤permeating facility 【coal ash】 | |
|---|---|---|---|---|---|--|---|--|---|---|---|
| | T-C(%) | 2.4 | 3.0 | 6.8 | 3.4 | 9.5 | 3.1 | 5.1 | 5.2 | 6.2 | 3.9 |

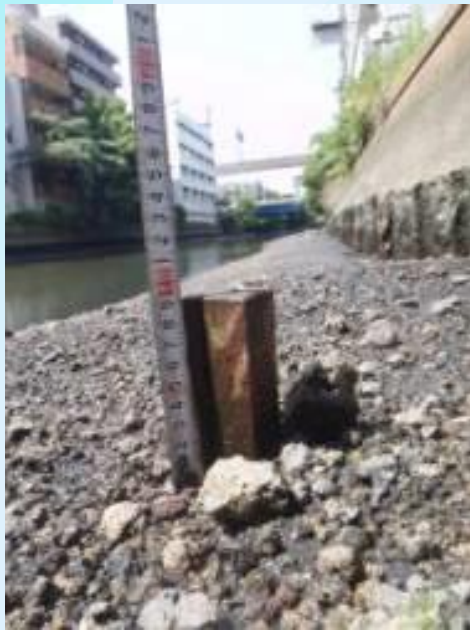
1. Durability of covering materials against river flow

Purification material and sand are covering in stable now.

Continuous observation would be needed until over flood season.

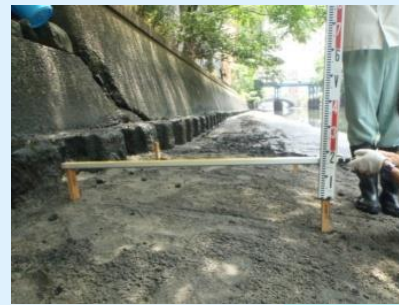
Higher angle (15%)

Higher angle of cover materials for river stream decreases deposition of sludge.

Few sludge deposited

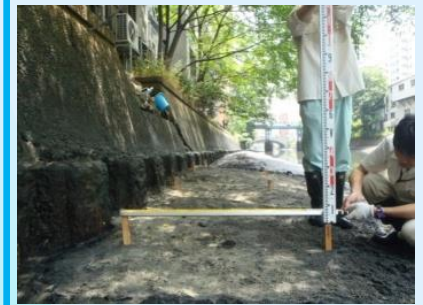
Lower angle (5%)

More sludge deposited

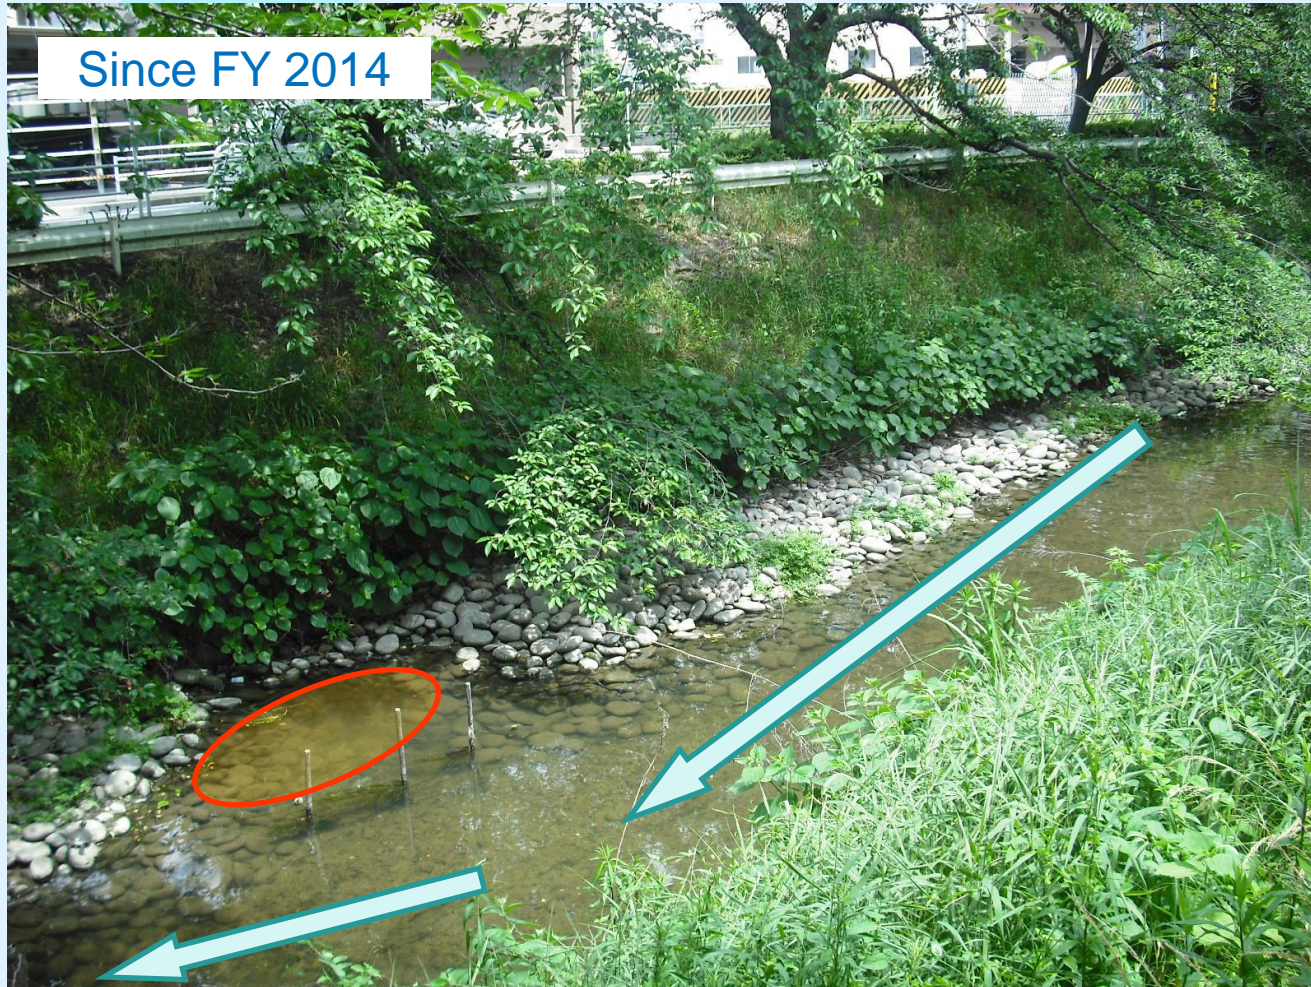
◆ Making shallows and abyss

Setting wooden piles and ripraps generates variable stream on the river for enforcing river's self-purification function with growth of plants.

fish spawning and
plant seed ashore

Change of stream

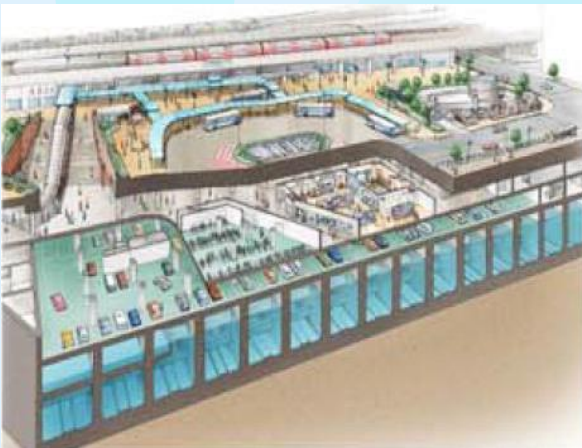
Ozone stormwater
reservoir

Construct rainwater storage facilities to reduce pollution load for Horikawa River in rainy weather by storing high polluted first flush rainwater temporarily.

Started operation in 2006
(12,000m³)

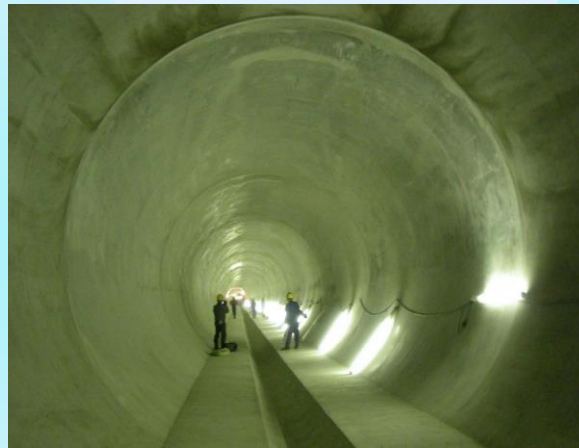
Horikawa Ugan Rain-
water Reservoir for
pollution control

Started operation in 2010
(13,000m³)

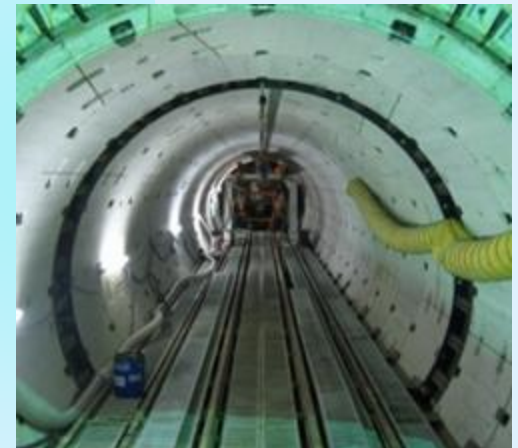
Horikawa Sagan Rain-
water Reservoir for
pollution control

Under construction
(14,000m³)

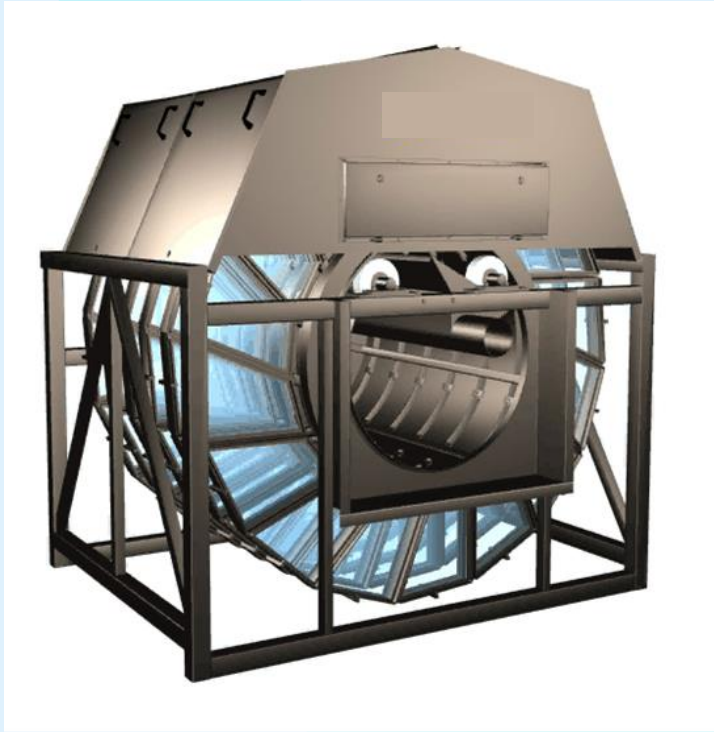
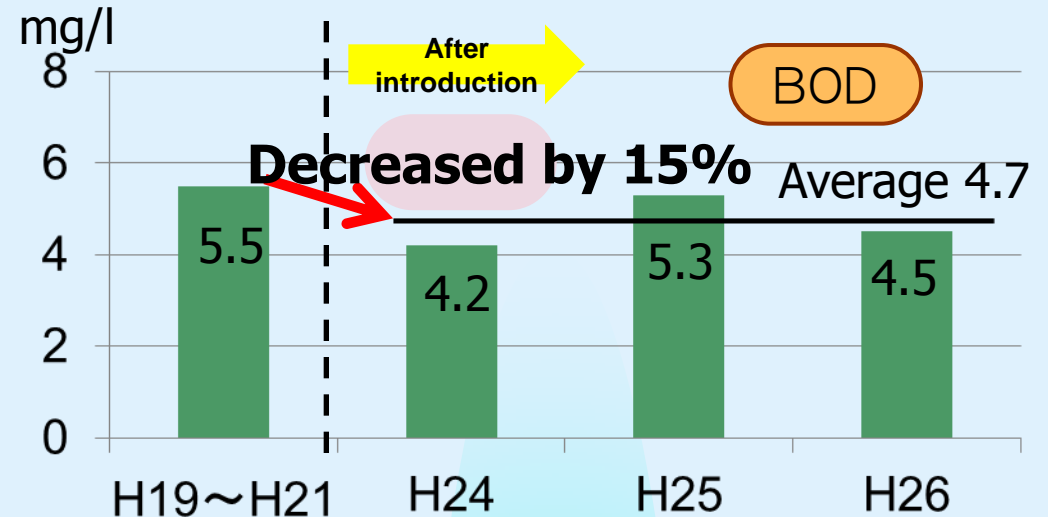
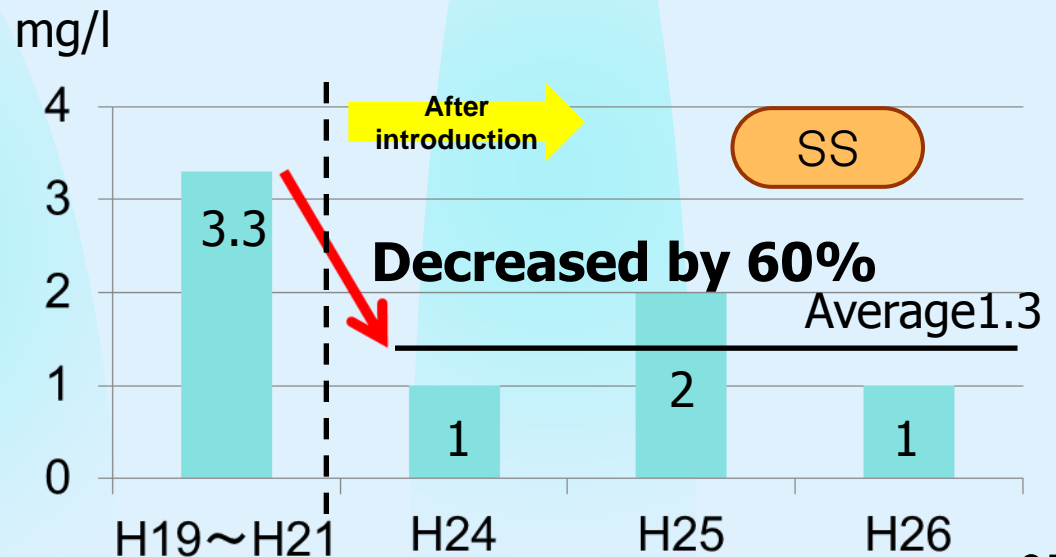
◆ Advanced water treatment at Meijo Water Treatment Center (Started operation in May, 2010)

Filter out more minute Suspended Solids(SS) in treated water by filtration devices

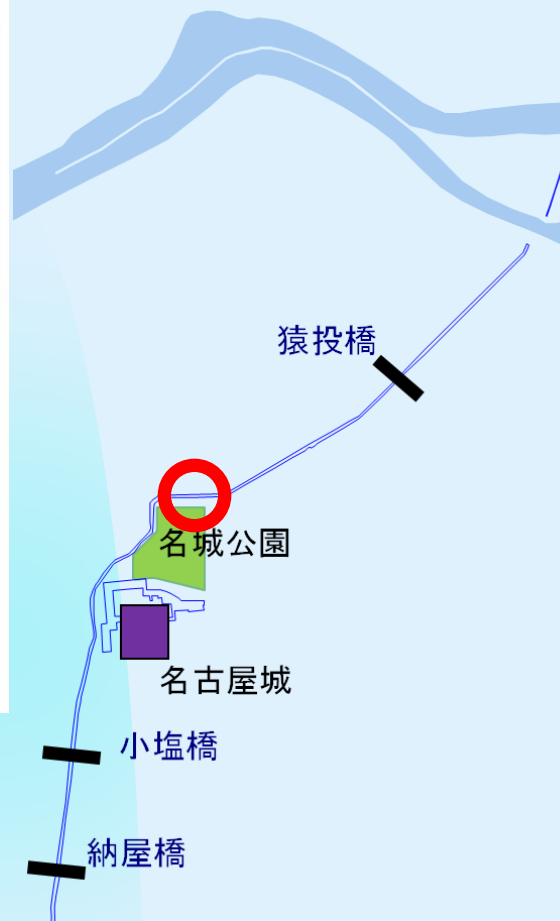
◆A Garbage Catcher(Near Johoku Bridge) Introduced in 2006

| The accumulation result in 2012 | 1.1 tons |
| in 2013 | 0.8 tons |
| in 2014 | 0.7 tons |

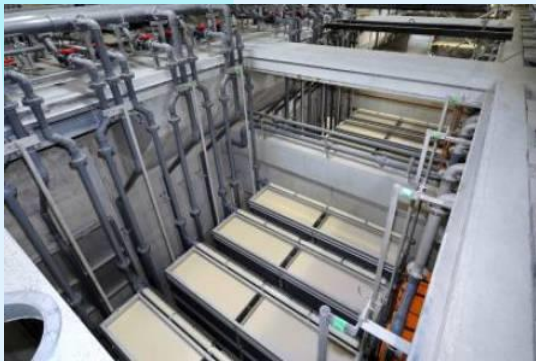
Use of reclaimed wastewater treated by the membrane filtration process at Moriyama Water Treatment Center

Flat membrane units
in aerobic tanks
(400 sheets × 12 units)

The membrane case
of an upper stage
(200 cartridges inside)

The membrane case
of a lower stage
(200 cartridges inside)
