Measures to make Horikawa River Limpid

Implementation by Nagoya City

Sep.3rd 2016

**Greenification & PublicWorks Bureau
River Planning Div.**

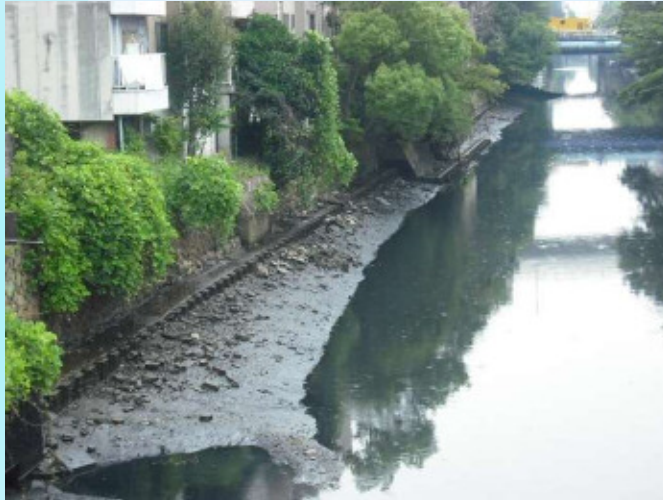
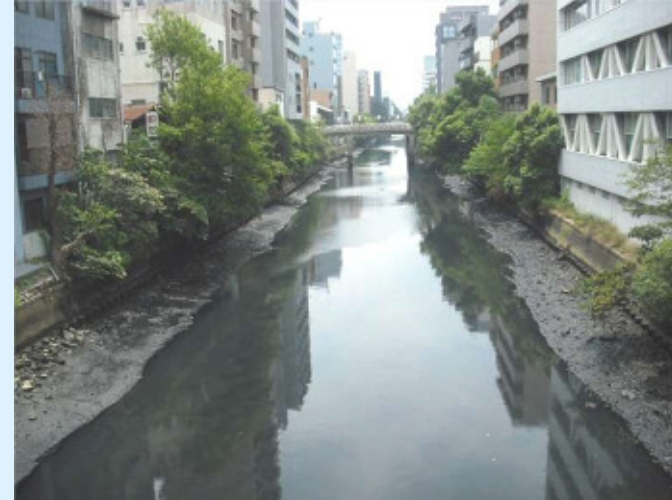
Sludge appearing from riverbed on the ebb tide.

We implemented several clarification experiments that focused on Sludge that appeared on ebb tide.

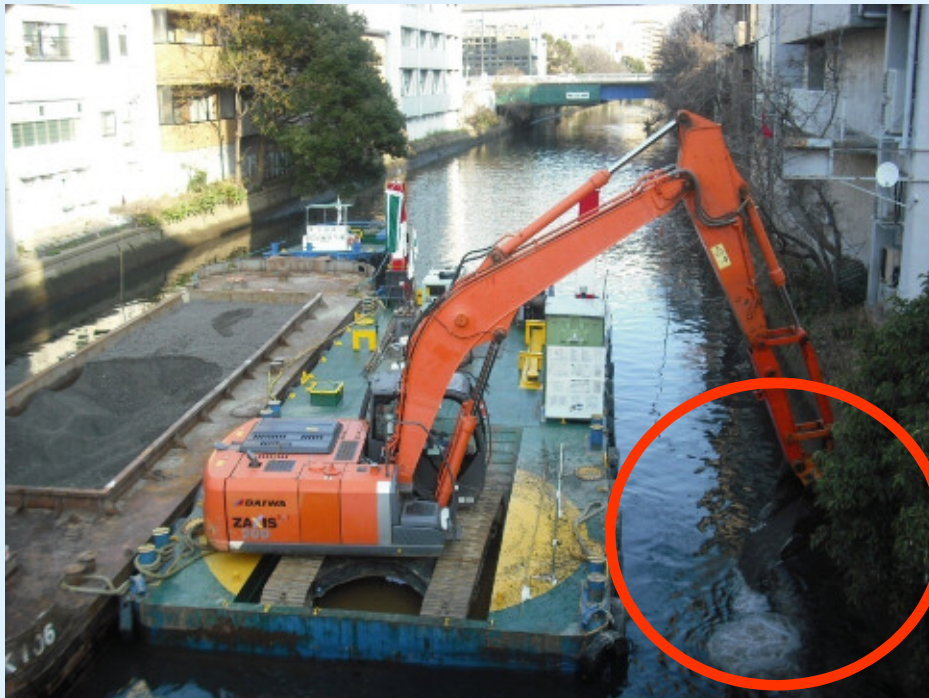
Construction of the experiment site

from Jan.16 to Jan.23

Machines set on a float constructed the experiment site.

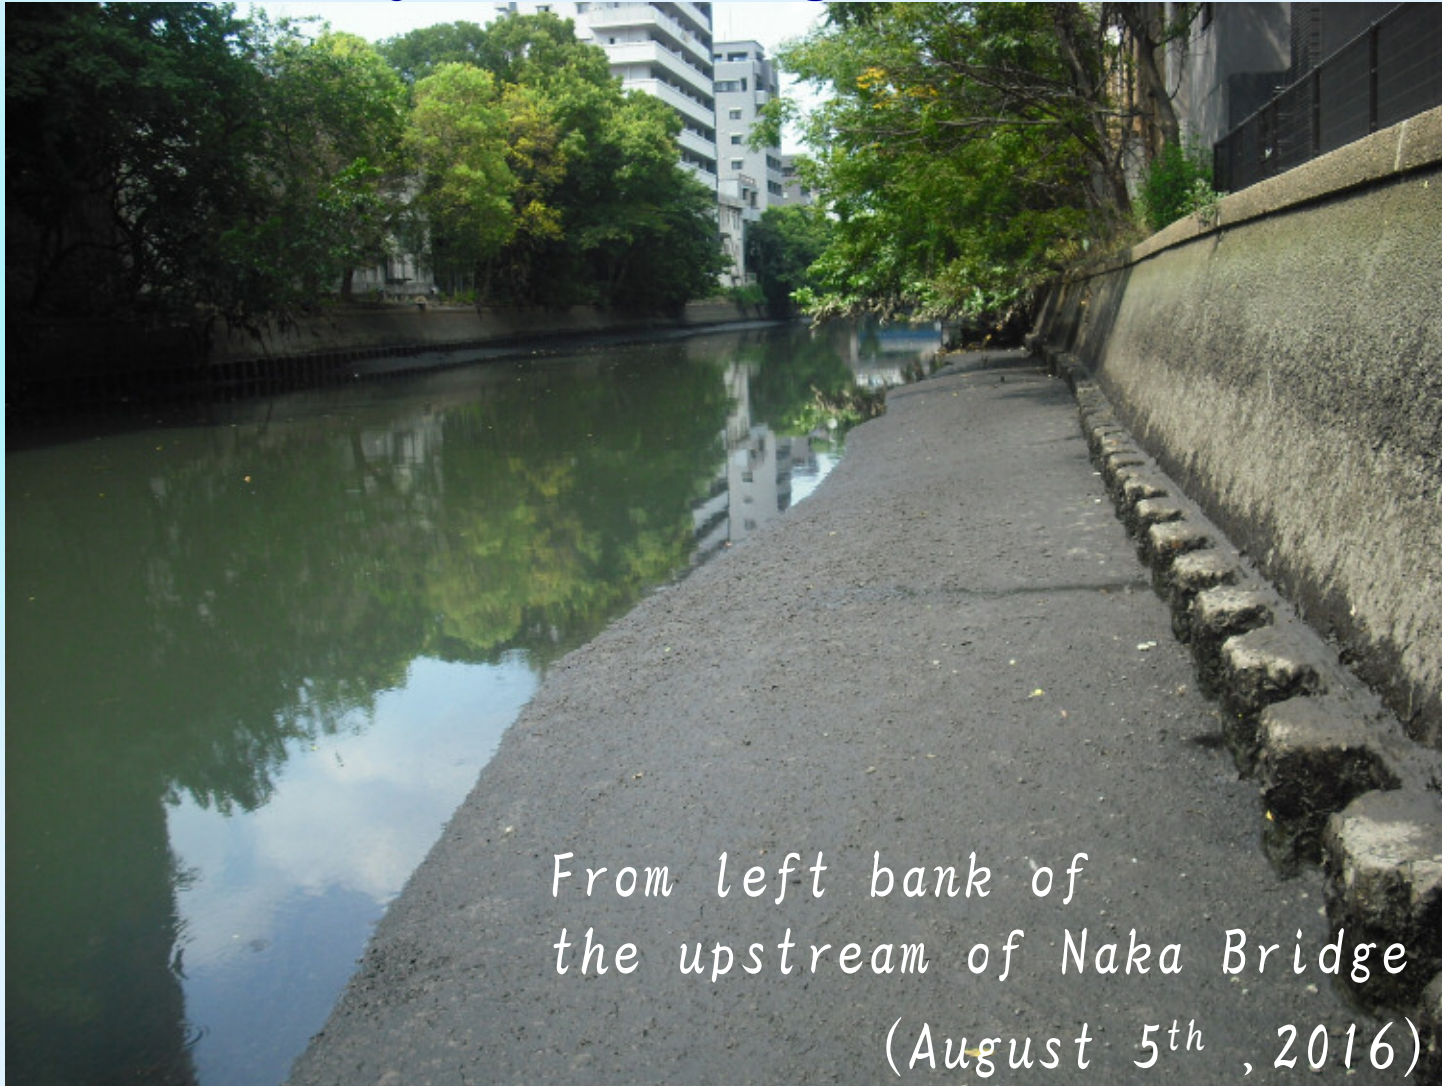
Situation of Clarification Experiments by Covering Sand

*From left bank of
the upstream of Naka Bridge
(August 5th , 2016)*

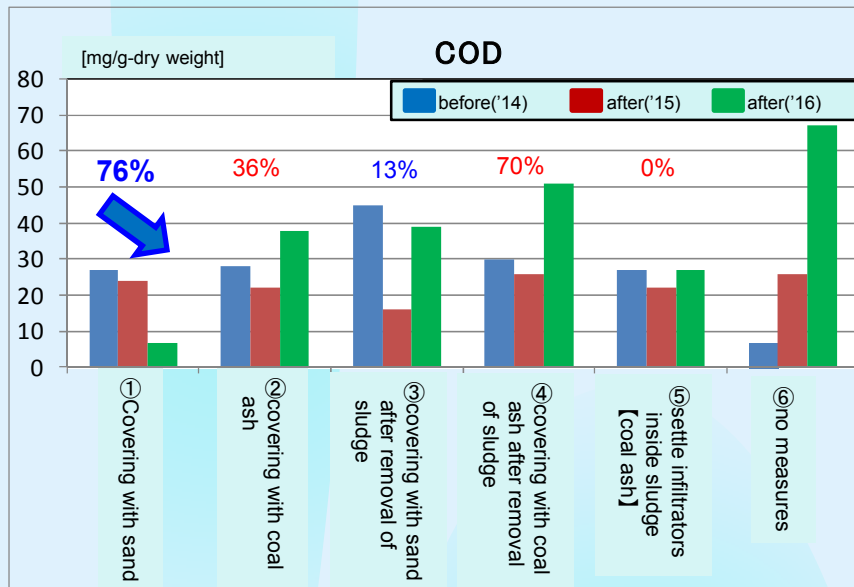
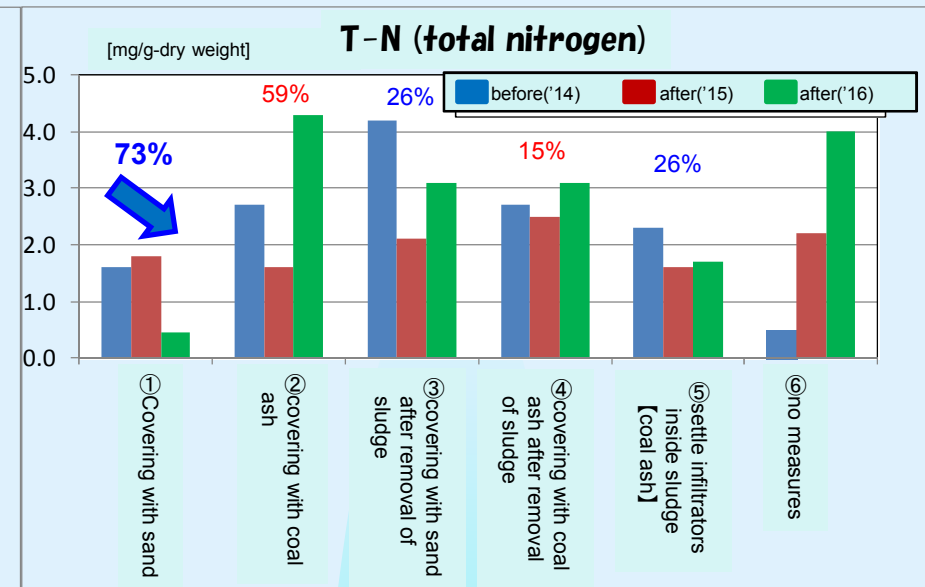
Monitoring Survey Result (bottom sediment)

➔ More than 70% improved

Blue#: improved

Red#: not improved

• pre-survey (before construction)
Aug. 25,26 2014

• post-survey (after construction)

1st : Jul. 31 2015 2nd : Jul. 4, 5 2015

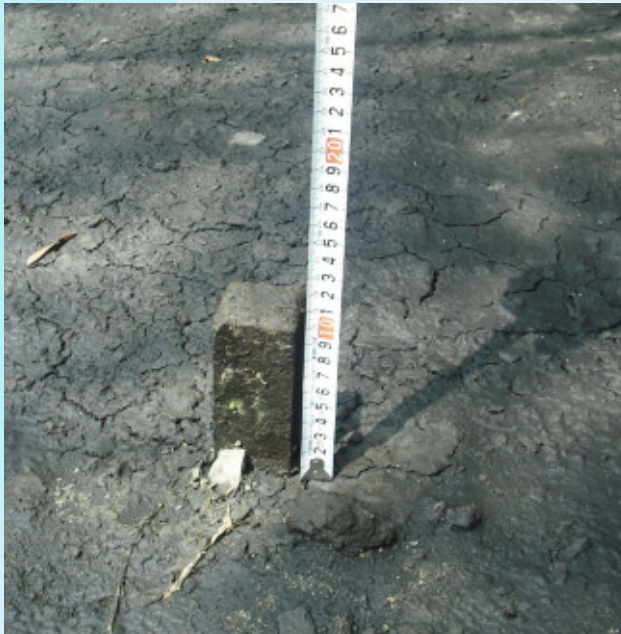
Monitoring Survey(effluence of cover)

○Survey of the effluence of covered
by the alteration of the tide level

Change(average)
The area covered with coal ash	-4.1cm
The area covered with sand	-1.0cm

※17 months after the cover

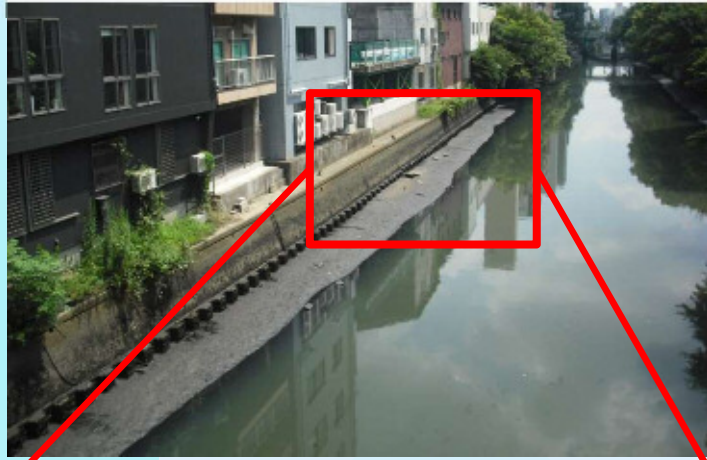
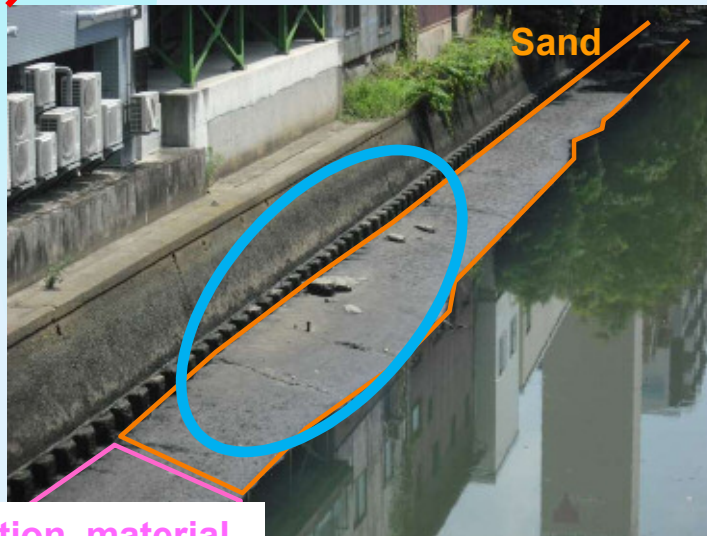
Gojyo Bridge, downstream, left bank

Purification material

Good condition sand could be confirmed at higher bank level.

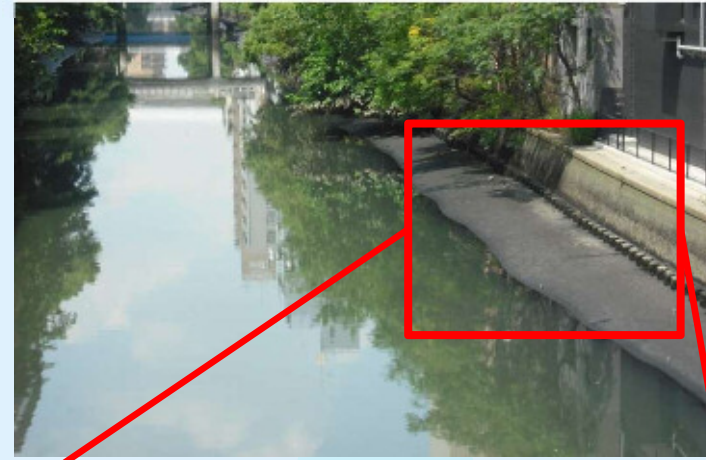
Naka Bridge, upstream, right bank

Purification material

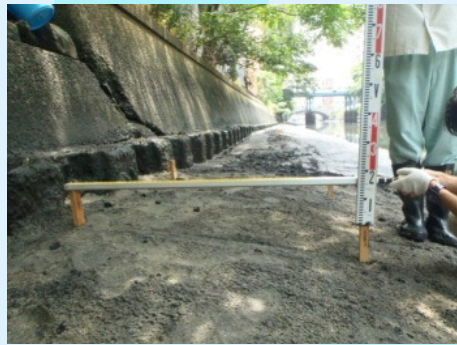
Steeper slope (15%)

Sludge at steeper slope could hardly be piled up.

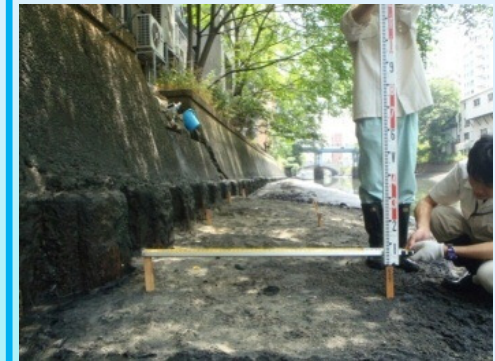
Gentler slope (5%)

Sludge had piled up.

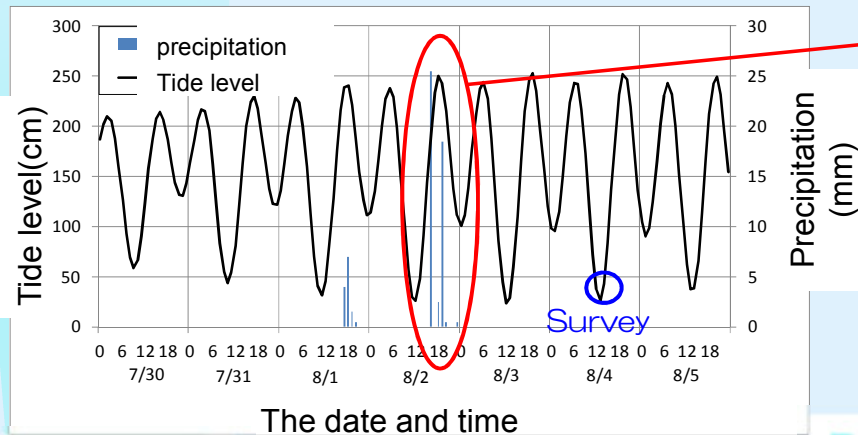
Change of sludge condition caused by heavy rain on Aug. 2nd

Rain condition Aug. 2nd 16:00 – 20:00
max 25.5mm/hour
Sum 47.5mm

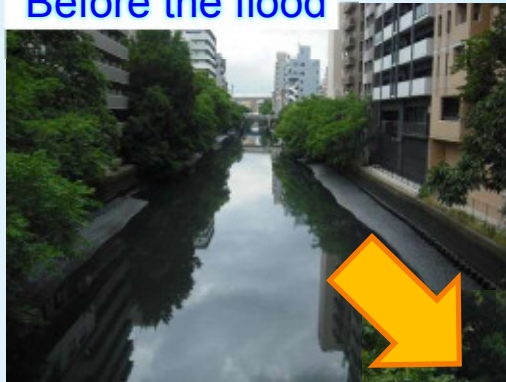
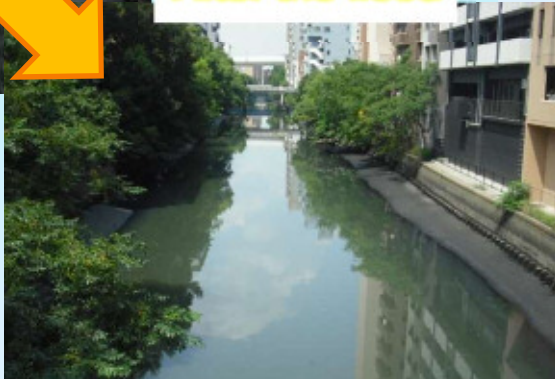
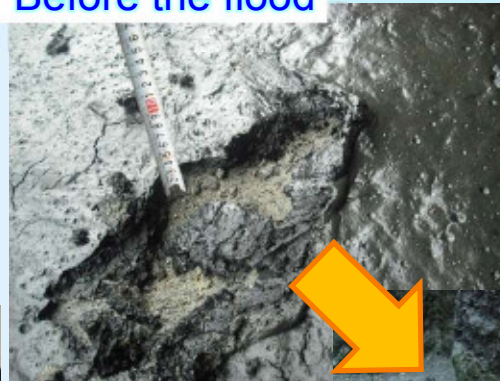
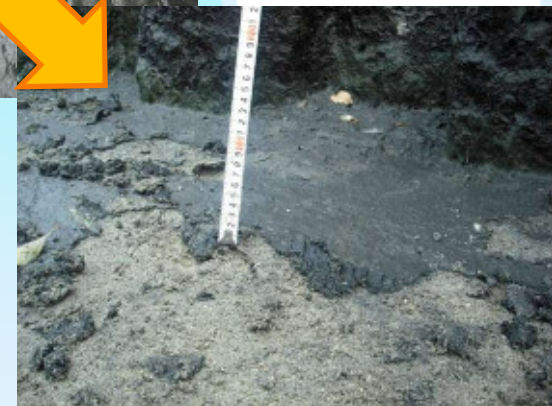
Sludge on the covering sand was washed away.
Covered area kept good condition.

Before the flood

After the flood

Covered area keeps some good level by rain.

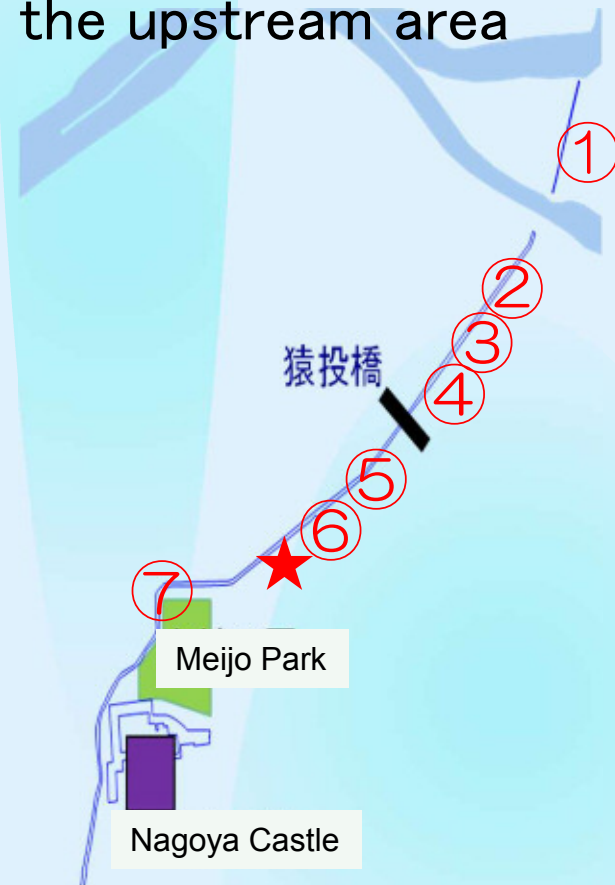
◆ Use of shallow ground water in the upstream area

★: scheduled survey point in 2016
(downstream from Tabata Bridge)

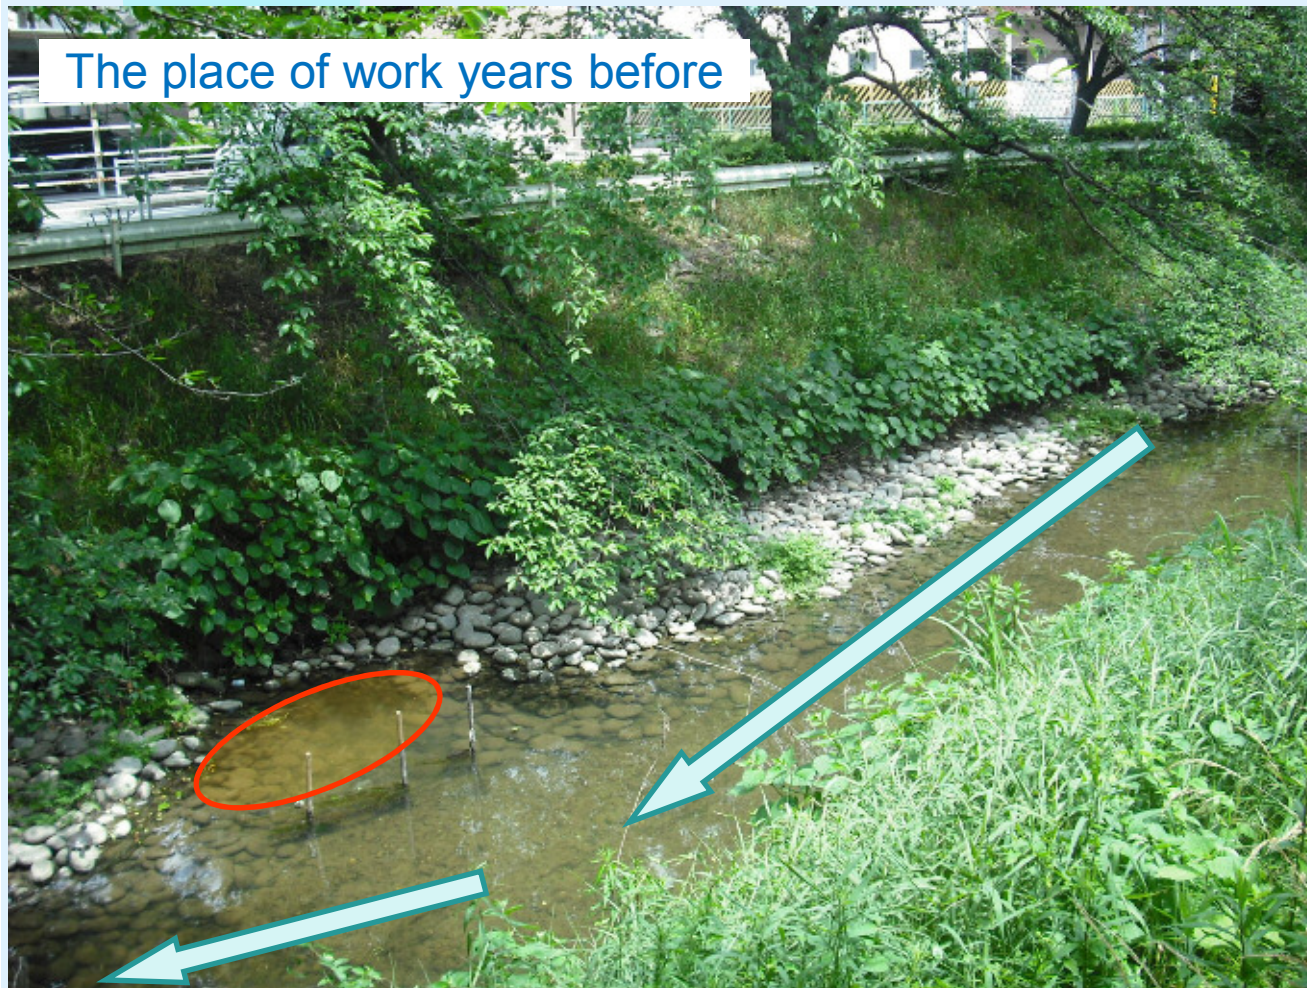
◆ Making shallows and deeps

Setting wooden piles and ripraps generates variable stream on the river for enforcing river's self-purification function with growth of plants.

fish spawning and
plants' seed ashore

change of stream

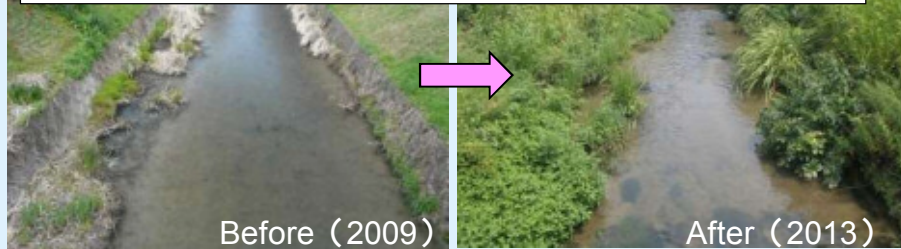
Installed in 2010
(Meoto Bridge~Kurokawa No.1 Bridge)

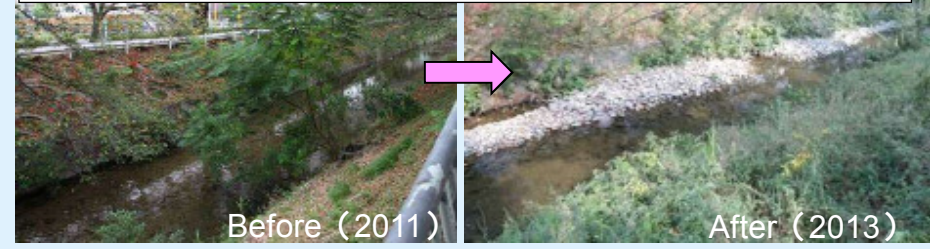
Installed in 2012
(Downstream of Kurokawa No.2 Bridge)

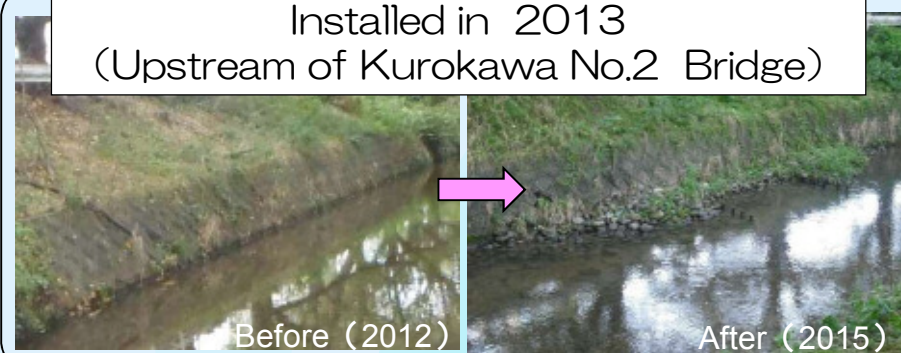
Installed in 2013
(Upstream of Kurokawa No.2 Bridge)

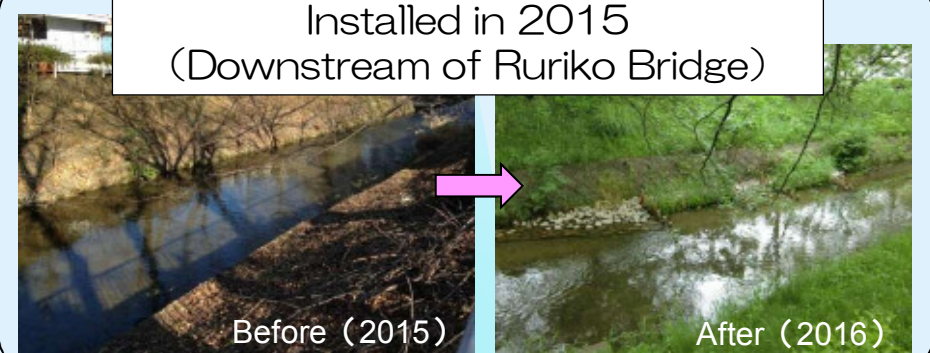
Installed in 2015
(Downstream of Ruriko Bridge)

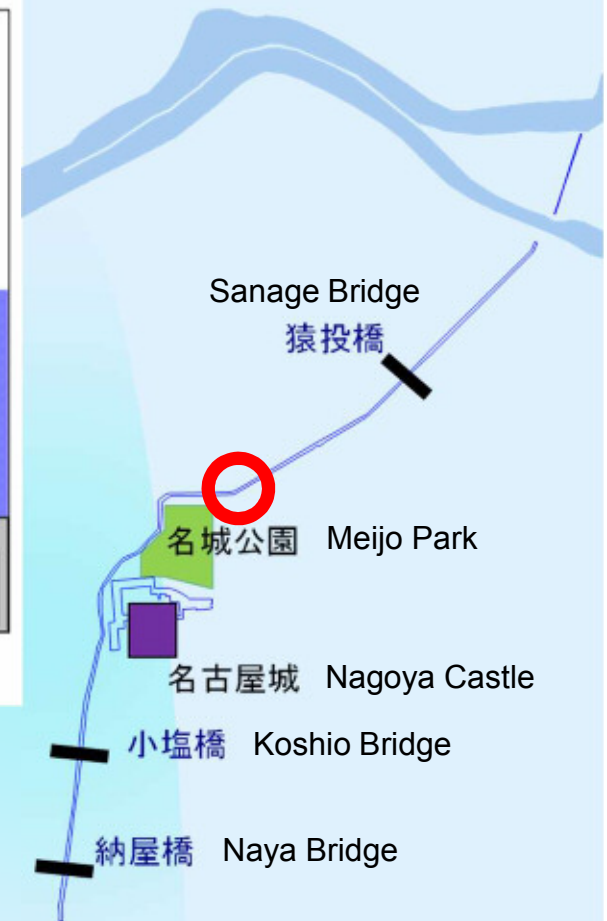
◆Garbage catcher (Near Johoku Bridge) since 2006

Result of collection in 2012	1.1 t
in 2013	0.8 t
in 2014	0.7 t
in 2015	1.4 t

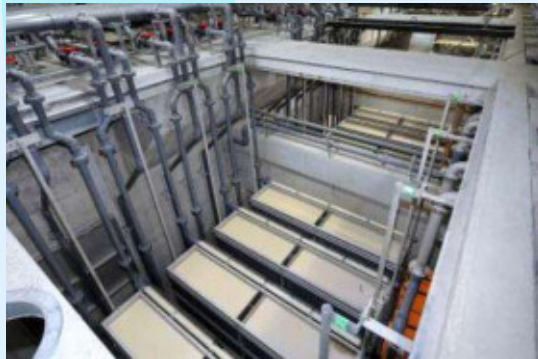
Conducting reclaimed wastewater treated by membrane filtration at the Moriyama Water Treatment Center

○ Water Supply: Up to $4,000\text{m}^3/\text{day}$ ($0.046\text{m}^3/\text{s}$)

Flat membrane unit
in aerobic tank

(400 sheets \times 12 units)

Upper stage membrane case
(200 cartridges inside)

Lower stage membrane case
(200 cartridges inside)

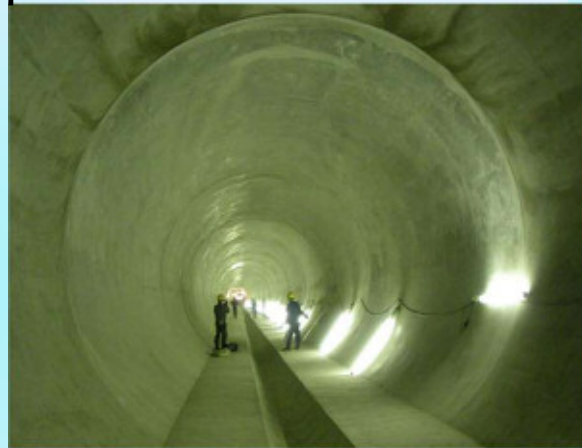
Horikawa Ugan Rainwater Reservoir for pollution control

Started operation in 2010
(13, 000m³)

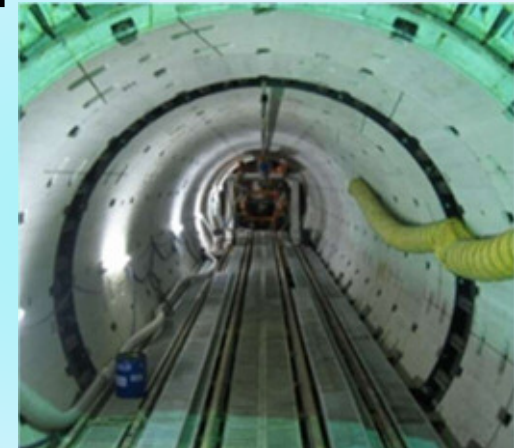
Horikawa Sagan Rainwater Reservoir for pollution control

Scheduled to start operation in 2018
(14, 000m³)

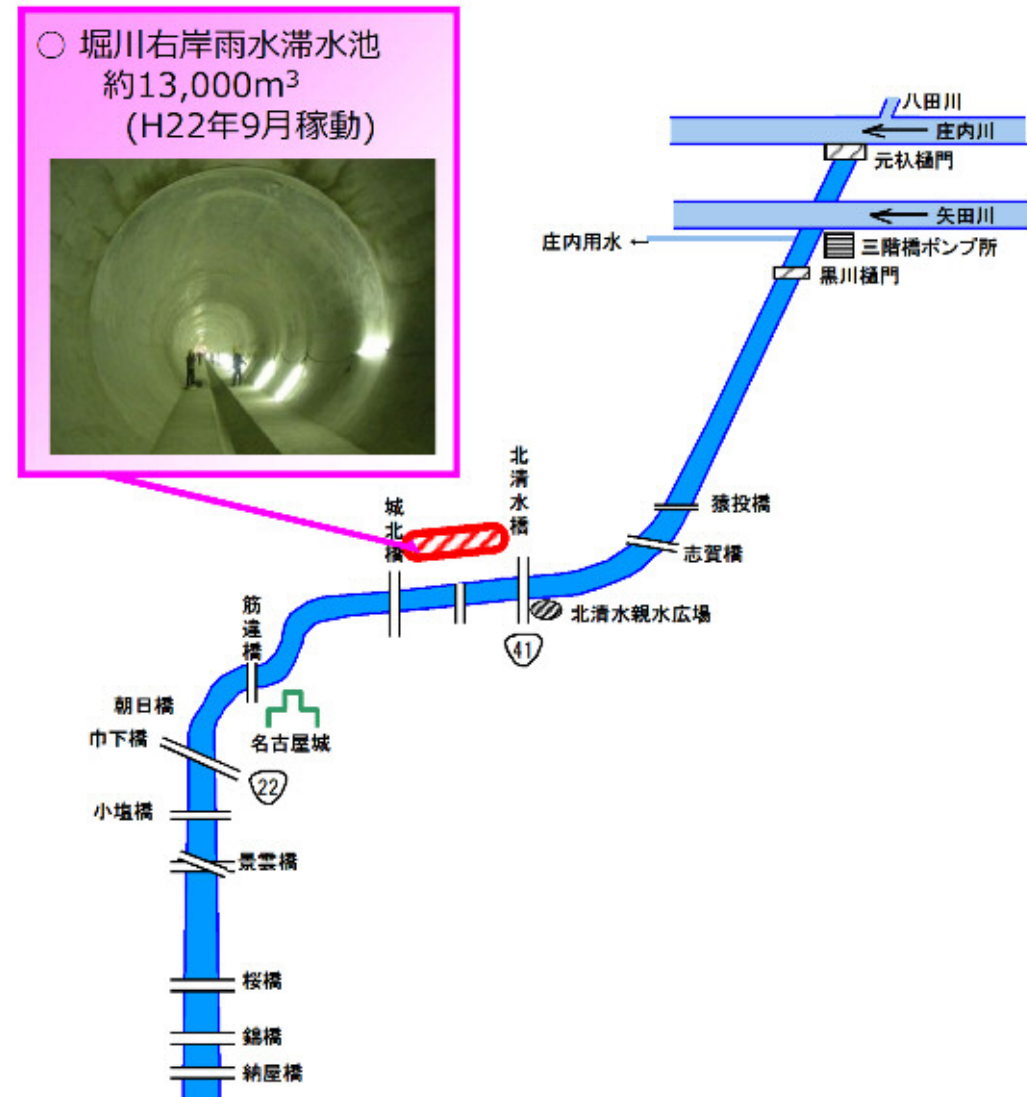
◆ Horikawa Ugan Rain-water Reservoir for pollution control

- Started operation in September 2010
- About 13,000m³

Cumulative stored water volume in fy 2015

About 680,000m³
