# Measures to make Horikawa River Limpid.

## Implementation by Nagoya City.

Feb.15th.2014

Nagoya City Greenification & PublicWorks Bureau River Dep.  
River Planning Div.

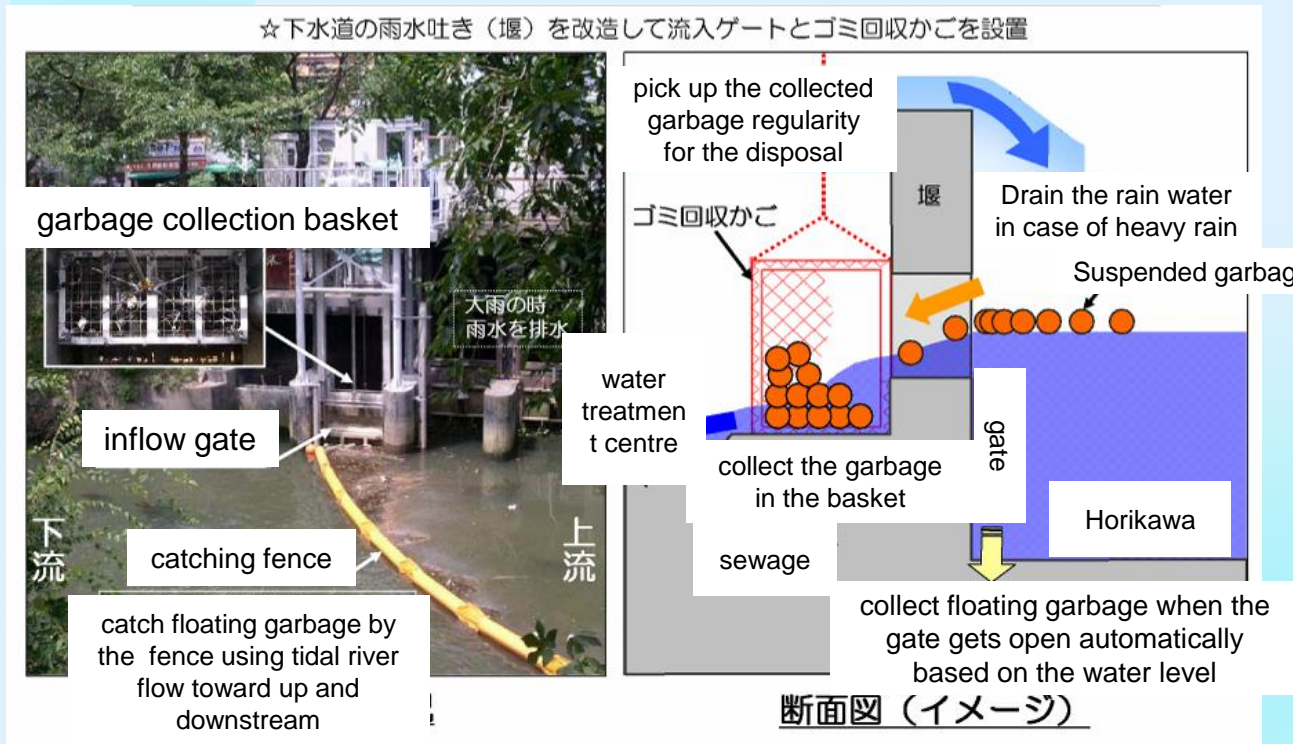
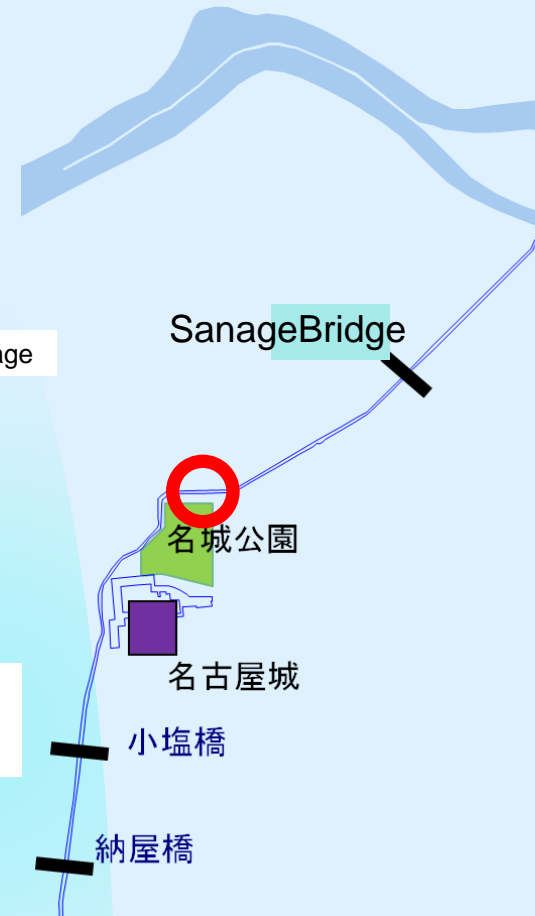
## ◆ Garbage Catcher (near Johoku Bridge) from FY2006

FY 2010 collected	2. 4t
FY 2011 collected	2. 3t
FY 2012 collected	1. 1t

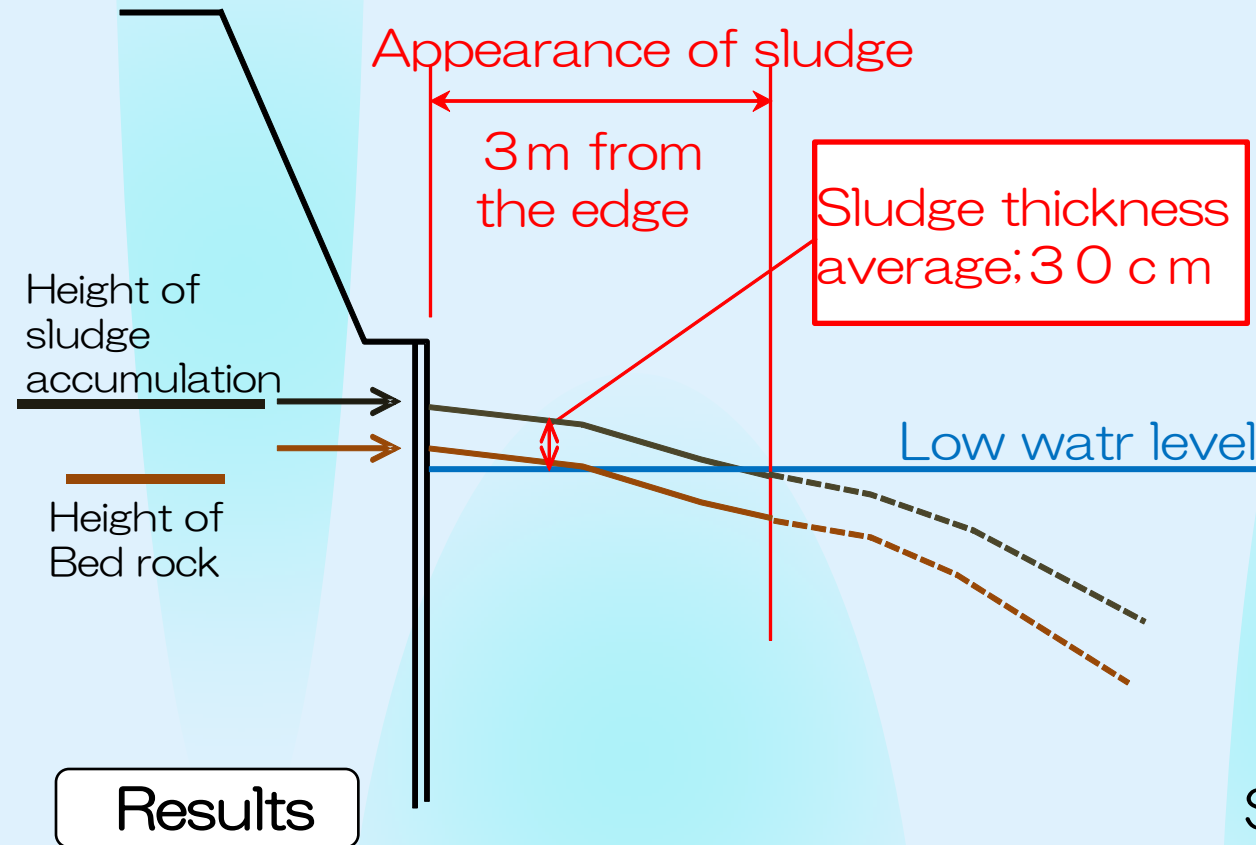
Sludge on surface

- Sludge layer is about 30cm thick on average (min 4cm, max 66cm)
- there are many stones on the lower layer at the almost all points

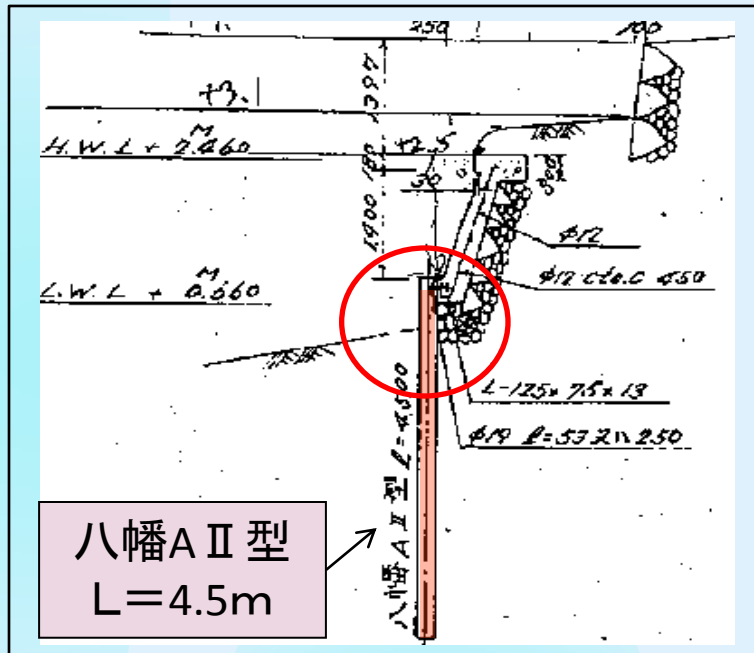
Structural Drawing (S7~8 established)

Becoming hollow at sheet pile damaged

- We found the standard of the sheet pile. The sheet pile has not been repaired and embedment depth is shallow.
- We found erosion of an exposed part and deteriorated part.
- As the result of this survey and the stability analysis, we found it hard to remove sediment on the sheet pile.
- Revetment become more instable when the water level is low.
